# Facilities Assessment STUDY

Dr. John C. Page Elementary School

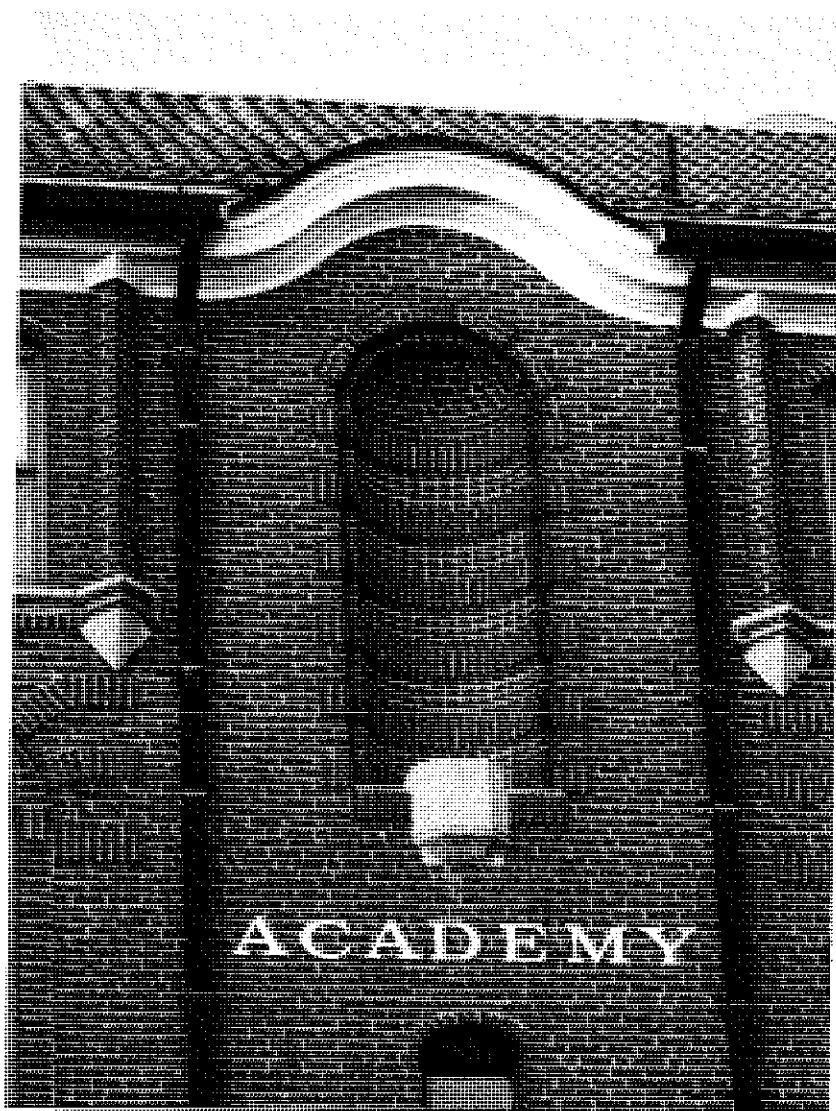
## **INTRODUCTION AND BACKGROUND**

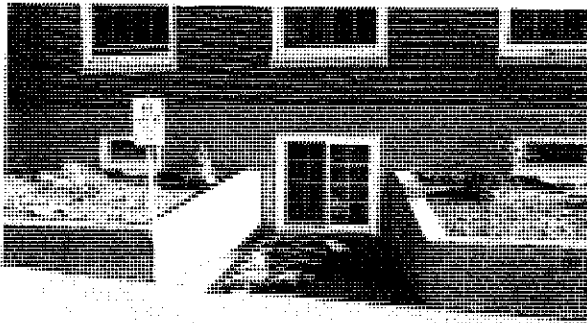
Movable speed bumps areas were observed in two locations, the first just east of the pedestrian crosswalk and the second located just south of the west end of the building west of the crosswalk at the ADA parking area. These were removed and stockpiled on-site for winter snow removal operations. See Photo's 7 and 8 below that show movable speed bumps stockpiled.

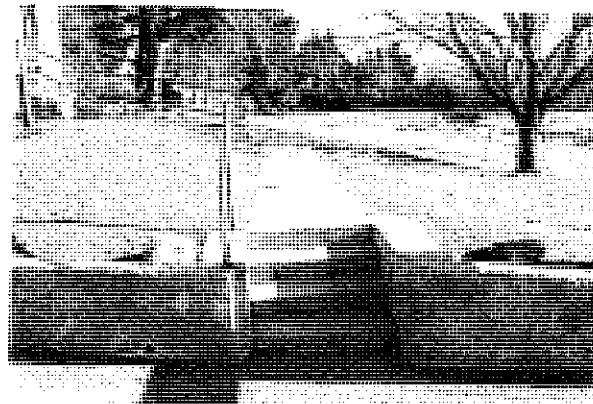
Door A1 services "The Children's Castle", which is a private facility utilizing the school facilities. This access is narrow and has two stairways to access the building. This appears to be the main entrance and does not meet ADA standards. See Photo 9 below. No ADA parking spaces are within close proximity to this entrance.

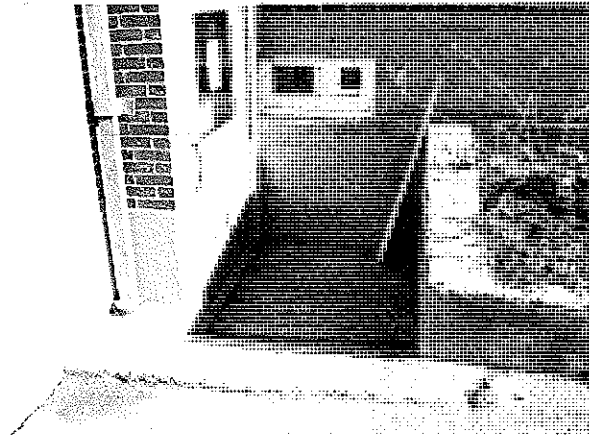
Door A2 services the kitchen area see Photo 10. This door access is a below grade with a wooden landing. The concrete from the foundation that forms the sunken landing extends above the pavement causing a trip hazard condition. It is unknown if a surface drain exists below the wooden landing. This area does not have a roof to protect it from snow or debris from blocking the door from opening.

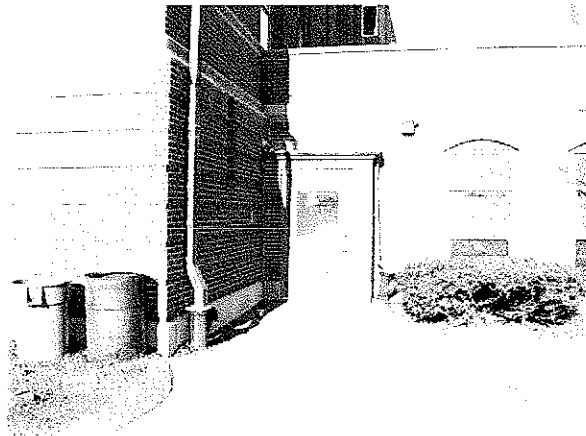
Door A3 accesses the cafeteria see Photo 11. This door is at grade and TFM was told is used as an alternative ADA access in winter conditions. Like door A2 this is not covered to the weather. If used as an alternative ADA access it lacks an automated door opener and ADA parking is over 100 feet away see Figure 2.

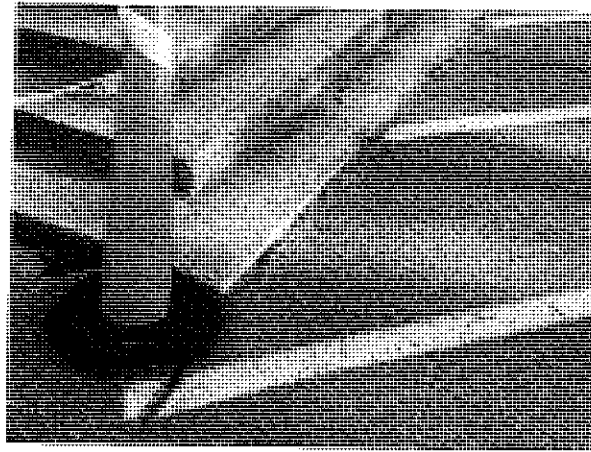
Door A4 is the main entrance to the School. It consists of a large concrete stairway leading from the main drive. The first riser has variations in height, which can cause a trip hazard, see Photo 12. The pavement in this area is the landing for the stairway. The stairs are uncovered and due to the sloped roof three-plus stories above, are likely to be covered by snow and ice as well as rain in stormy situations. Stair surfaces did not have any special treatment to reduce slipping.

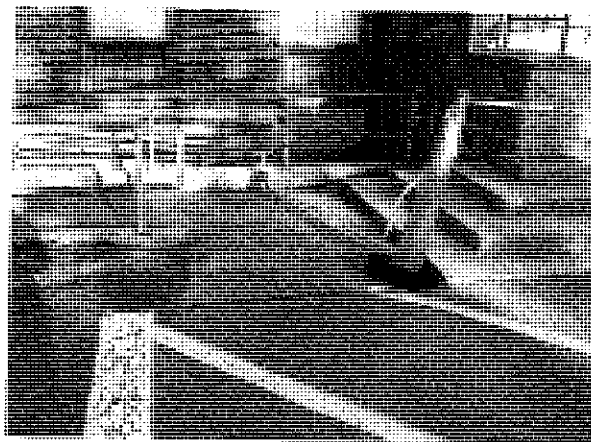
Door A5, which is below the stairway of A4 is the ADA access to the school. To access A5, there is a ramp that is entered to the left of the stairway for A4. The ramp is made up of pavement and concrete and is separated by a landing where the ramp changes directions. The ramp has many uneven surfaces that would cause issues with a wheelchair as shown on Photo 13. Like A4, door A5 and the associated ramp is not covered to the weather conditions and did not have a treatment that would reduce slipping. The ADA parking area is located opposite this access, which consists of four striped spaces. These spaces lacked space for a van.

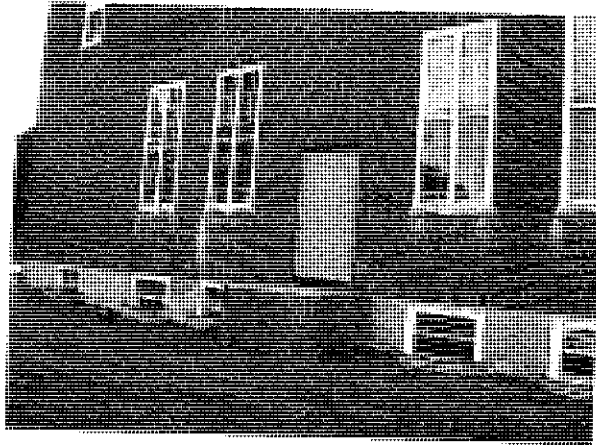
The unnumbered door, shown in Photo 20, located on the east side of the gymnasium is approximately 4 feet above grade. There is a concrete landing which is also 4 feet above grade that has no railing protection. It is surrounded by grass and does not look to be used. There are no outside stairs that access this landing.

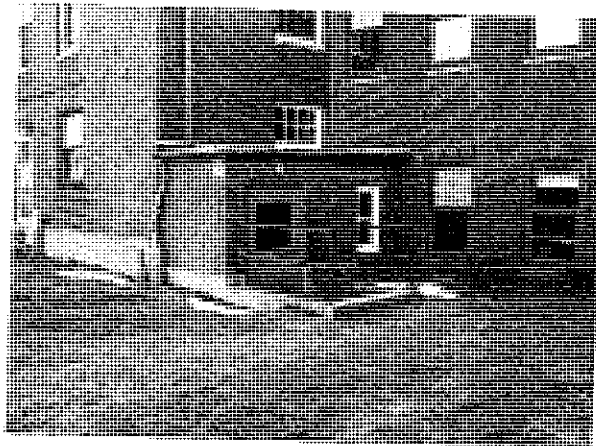
Door D1 appears to service the lower level that The Children's Castle occupies. There is an areaway access of four concrete steps surrounded by a concrete foundation with a concrete landing and steel rails. A small drain is located in the landing. There is no protection from the weather. The concrete foundation extends above grade, which requires someone to step over to access the first step. This directly accesses to a grass surface with no walkway. See Photo 21.

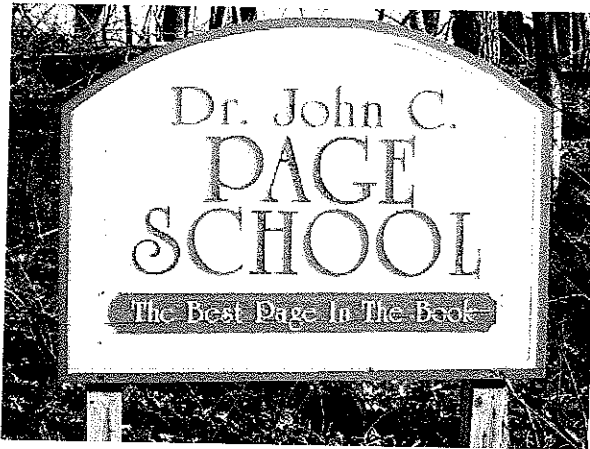
Signage on the School grounds consists mainly of directional signage in various conditions. At the main access drive two identification signs welcome visitors to the school. See Photo 28 below, which shows the sign located on the east side of the access drive. These signs appear to be in good shape and do not obstruct any sight lines for exiting traffic. There are many signs that line the access drive and elsewhere around the site that are illegible due to fading as shown on Photo 29. Other signs are damaged and are leaning into travel lanes can be seen in Photo 30. Landscape materials obstruct some of the signage at the entrance of the student drop off area, which is shown on Photo 31.

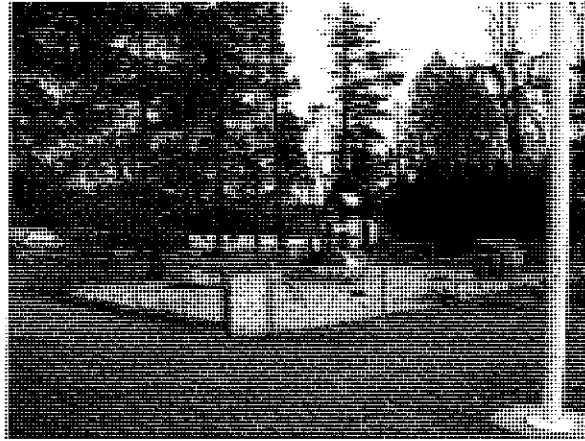
Multiple playgrounds are located on the school grounds. Although the condition of the playground areas themselves was reviewed, the specific equipment condition was not reviewed at this time. The first area encountered is located opposite the upper parking area next to the flagpole. This area, shown in Photo 32, was small in size and enclosed by a 4-foot high chain link fence with two gates. The lower gate was closed and locked while the upper gate located closest to the upper parking area was open. The surface was treated with woodchips. No shade structure was present. Trees are present in the surrounding area; however, TFM did not assess conditions at the time of the site investigation.

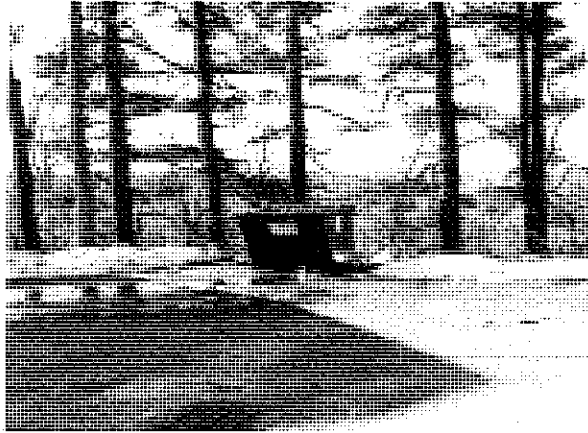
Garbage dumpsters were observed in three separate areas of the site. The first was located in the paved area between the old DPW Garage building and Recreation building. It is unclear if this is the School's or the Town's dumpster. The dumpster is in the direct line of site from the main access drive in front of the school; it is not in an enclosure or protected from vehicle traffic. See Photo 38. Trash was observed on the ground in the surrounding area.

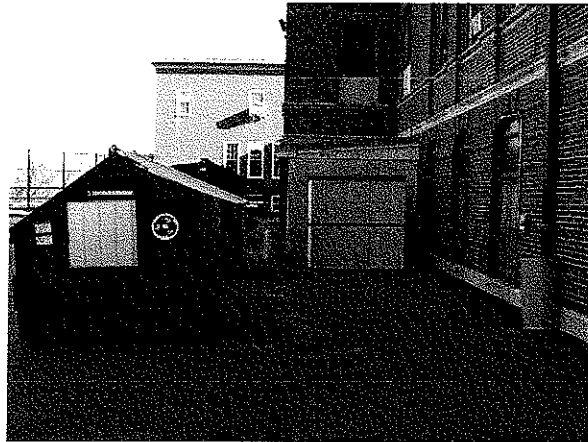
The next two dumpsters observed were located between door C1 and C2, which are shown in Photo 39. It is not clear if these are permanent dumpsters for school use or only during the Christmas vacation break. If permanent, these also are not located in an enclosure or are protected from vehicle traffic. There is also a possibility that the dumpsters could cause damage to the building if pushed while being emptied.

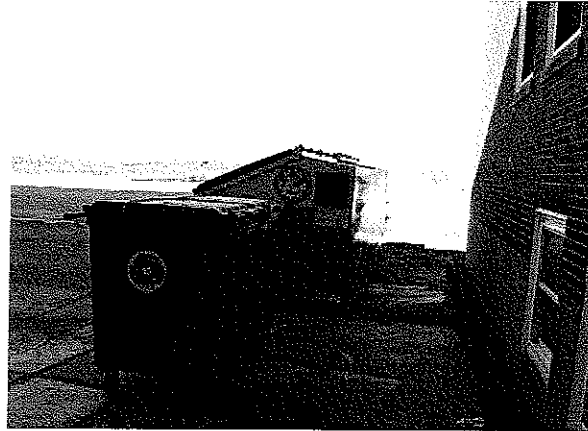
The third location of dumpsters was observed outside of door C3 (side of building typical). These two dumpsters appear to service the cafeteria. Like all of the other dumpsters, they are not in an enclosure or protected from traffic and could be pushed into the building. They are also located within a few feet of the door that services the gymnasium and on top of a pavement drawing of the United States, obviously used by the students. See Photo 40.

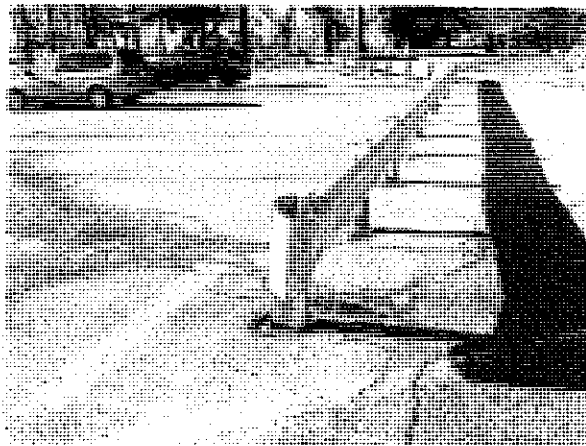
The site has a few areas that utilize steel guardrails as vehicle separators within the lower parking lot. These appear to be in relatively new condition and based upon our site observation, only showed one "G"-style end unit damaged at the entrance to the student drop off area, see Photo 41. There were a few areas that TFM feels additional guard railing should be added. These areas will be discussed in our recommendations.

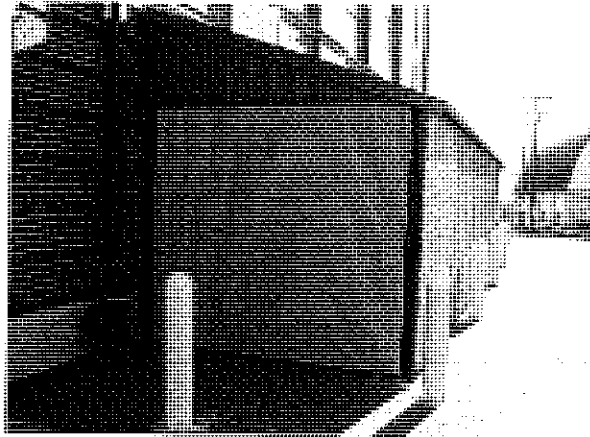
The outside heating fuel and propane enclosure is attached to the west end of the school building and is located on a paved surface that is a part of the access driveway. The enclosure has a metal roof and sides are made up of chain link fencing with woven slats. The enclosure does have an access gate/door that is not secured. Bollards covered with slip over plastic covers yellow in color protect the structure. See Photo 42.

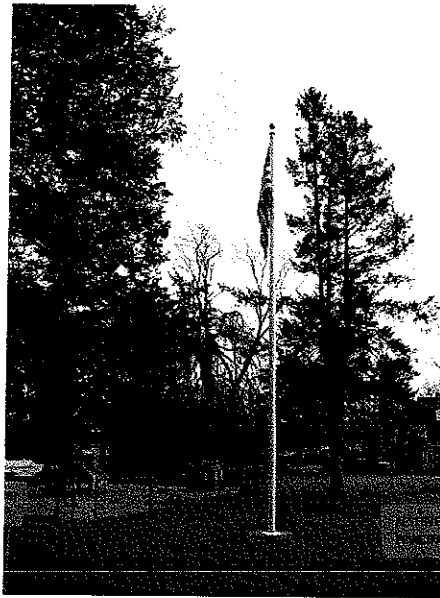
A flagpole was observed south of the upper parking area next to an enclosed play area and is shown in Photo 43. The pole did not appear to have a light. The pole appeared to be in excellent condition.

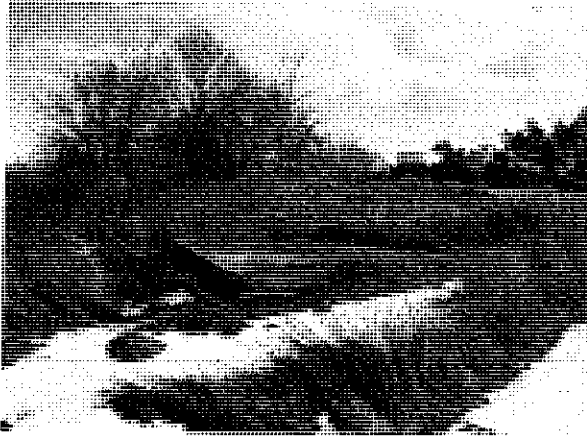
There was evidence of an old rope tow and an old ski hill behind the sports fields. The building pad, Photo 44, poles, Photo 45 and an abandoned fuel tank, Photo 46, were observed. The old pad and poles have remains of electrical wire and boxes. The pole closest to the sport field does have damage caused by vandals from chopping see Photo 47. Other poles from the top of the hill to the Indian River were also observed but were not structurally evaluated at this time.

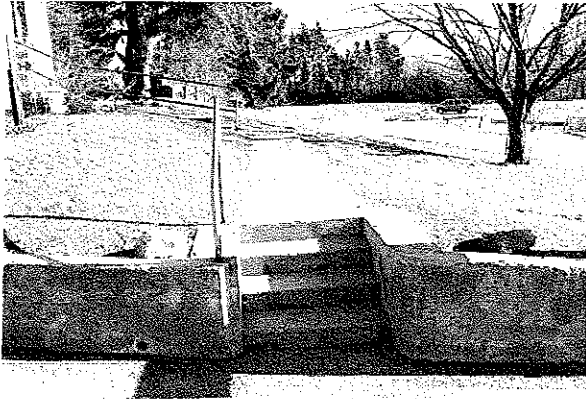
Two types of retaining walls were observed on site. The first is a concrete stem wall that separates the paved access drive and fire lane from the slope in front of The Children's Castle. Concrete steps that access door A1 are cast in this wall along with a handrail. The wall continues along the pavement and ties into the Children's Castle building at a lower window. It continues on the other side of the window to Door A2. This wall has weep drains and no cracks were noted at the time of our visit; however, portions of the wall show signs of chipping and deterioration. See Photo 48 and 49 below for examples of this wall.

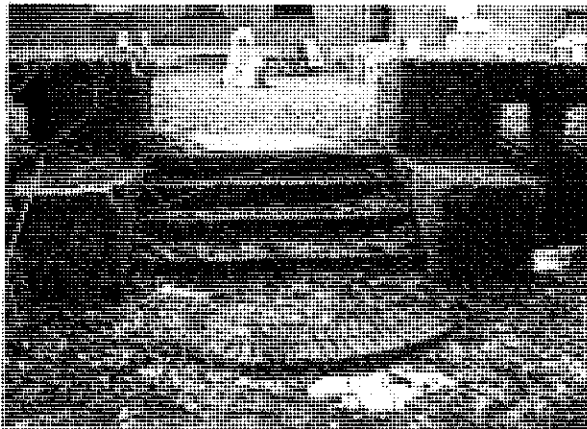
The second wall is an old brick wall that is located to the east of the Children's Castle building. This wall is decorative in style but is used to create two flat areas that seem to be used by children from the Children's Castle. These walls have loose brick and mortar. A set of steps are incorporated in a section to this wall that are in poor condition and do not have any handrail as shown in Photo 50. Other sections of the wall are approximately 1 to 2 feet above grade on one side and over 4 feet on the other side with no fencing or fall protection provided, which is indicated in Photo 51 below.

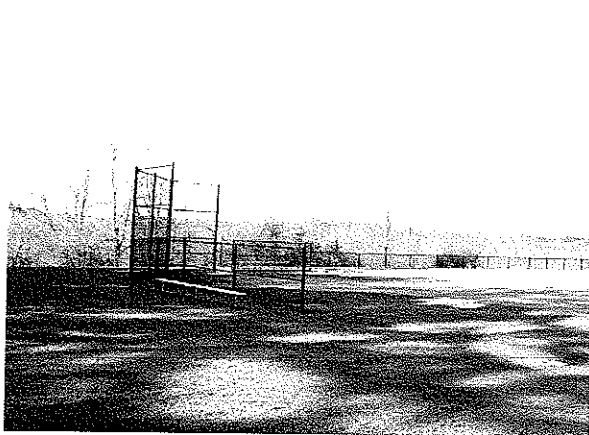
There are two sports fields in the rear of the school. These fields appear to have up to date fencing and benches. See Photo's 52, 53 and 54 for examples. The fields appear to be graded to allow surface water to runoff. A small storage shed, shown in Photo 55, is present north of the recreation building behind the western most sports field. No lights were observed that would allow for nighttime activities. TFM observed irrigation equipment around the perimeter of the fields, which would indicate that they have irrigation. TFM did not analyze the irrigation system during the site inspection due to snow cover and wintertime conditions.

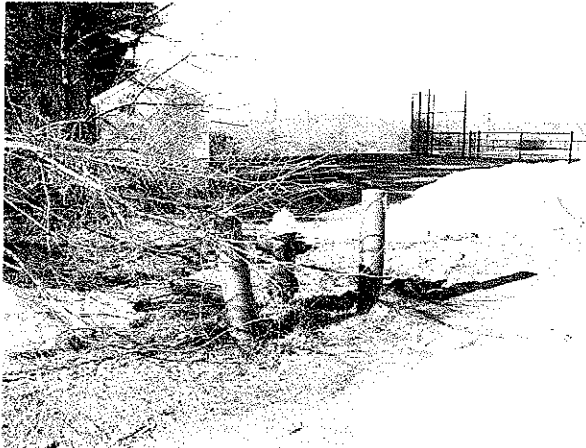
hydrant are leaning and appear to have been disturbed, likely by vehicles. A third fire hydrant was observed along the east edge of the access drive, which appears to be fed from the water tank as seen previously in Photo 58. A post indicator valve (PIV) see Photo 61 is located behind the gymnasium. It was leaning and appeared to have been damaged. The valve indicated it was open. It is unclear what this PIV controls. Portions of the school building has a fire sprinkler system, which has a connection that is located outside of doorway C1 for the Fire Department. This can be seen in Photo 62 See Plumbing and Fire Protection Section of this report for further information on these systems.

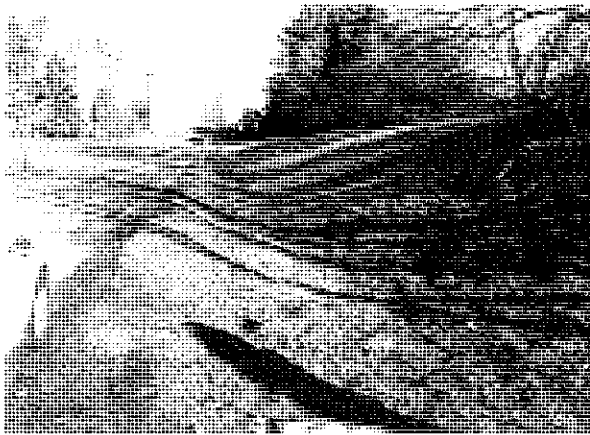
The school is situated on top of hill and generates surface runoff over in all directions. There are four enclosed drainage areas that were observed over the school site. The building has a roof gutter system that drains into an underground collection system. These downspouts appear to tie into three enclosed systems. It was not determined how these drains were separated. The first drains are located at the base of the entrance road on each side. A roadside ditch extends along both sides of the access drive to a point where the entrance to the lower parking lot is. These swales are grass lined with small diameter stone just above the catch basins. This system feeds into the Route 113 drainage system. See Photo's 63 and 64 for examples.

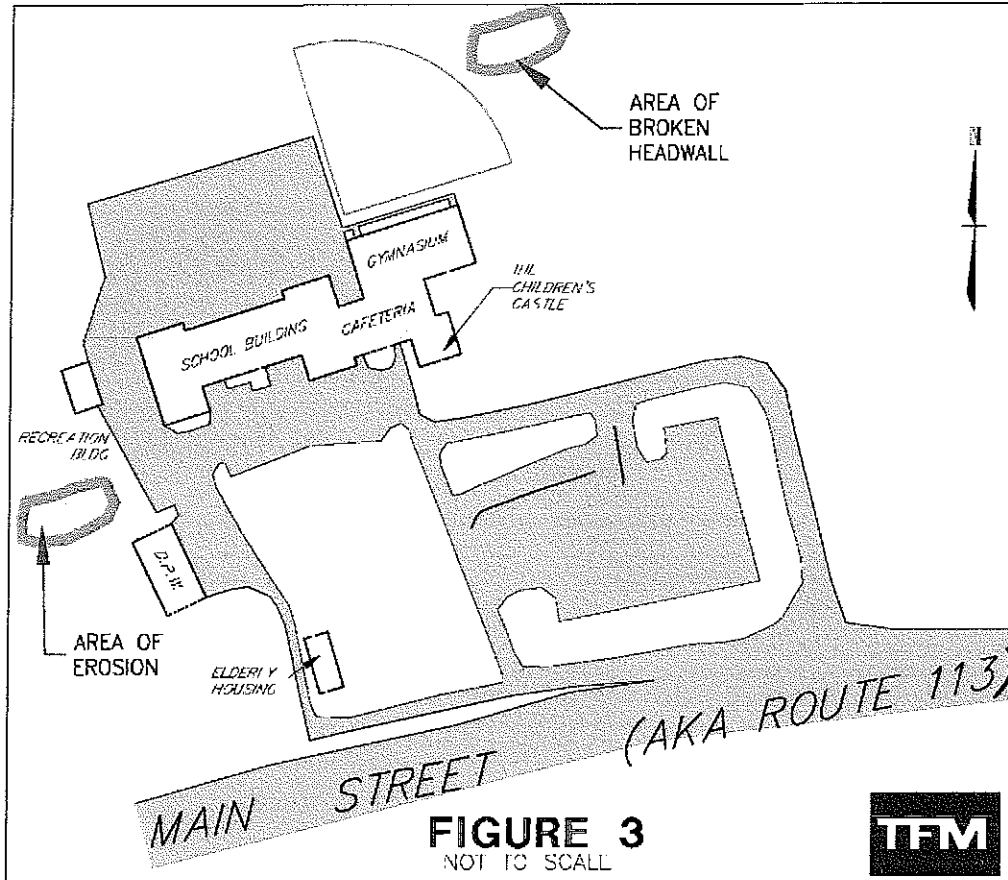
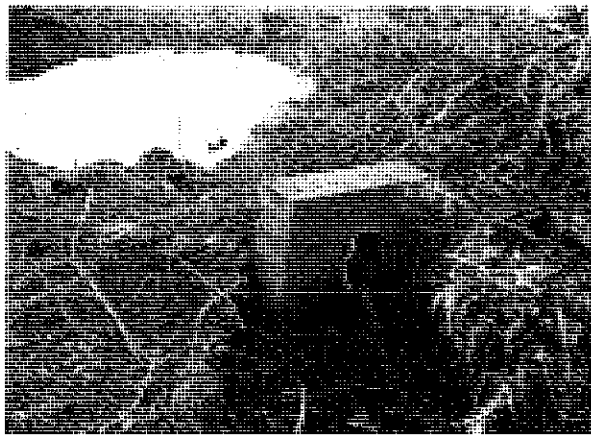
The fourth area has a little more uncertainty to its makeup. A manhole exists off the northeast corner of the gymnasium. The cover was unable to be removed for verification. A number of roof downspouts in that area are assumed to flow into the manhole. An outlet was observed northeast of right field on the northerly ball field over the slope, which is shown on Figure 3. The pipe appeared to be vitrified clay and was deteriorated. The area surrounding the headwall was severely eroded causing the headwall to break away from the culvert this is shown in Photo's 69 and 70. Significant water was flowing at the time of the observation assumed to be from snow melt from the flat roof of the Gymnasium.

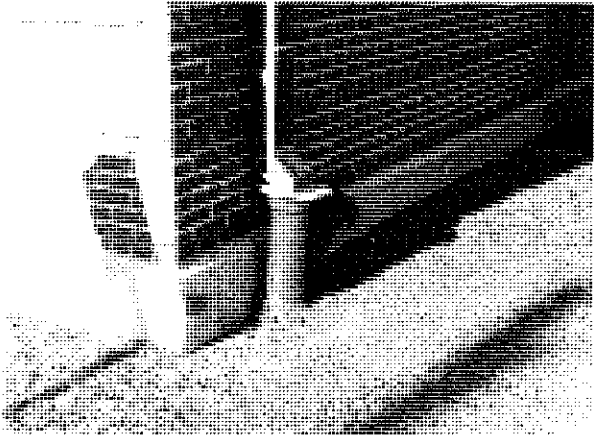
The roof drain collection system at the ground surface had many places where the connections were broken, dismantled and had open covers. See Photo's 71 thru 75 below for samples.

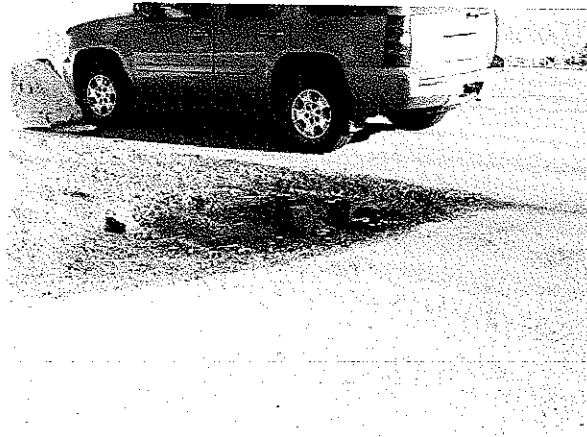
The lower parking area does not have any enclosed drainage structures and is assumed that the runoff sheet flows to surrounding areas. Pockets of water from recent snowmelt were observed within this area. A sample of one pocket is shown in Photo 75 below.

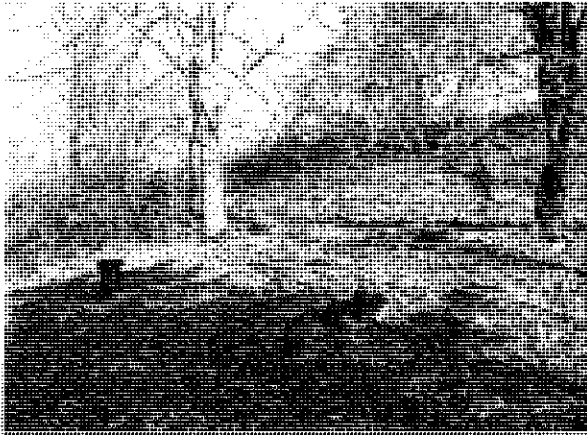
TFM noted trees growing over the sewer lines, tanks and dosing chambers, examples are shown on Photo's 78 and 79 below. The cleanout manhole covers have grass and soil over most of the cover making them hard to locate and remove for inspections.

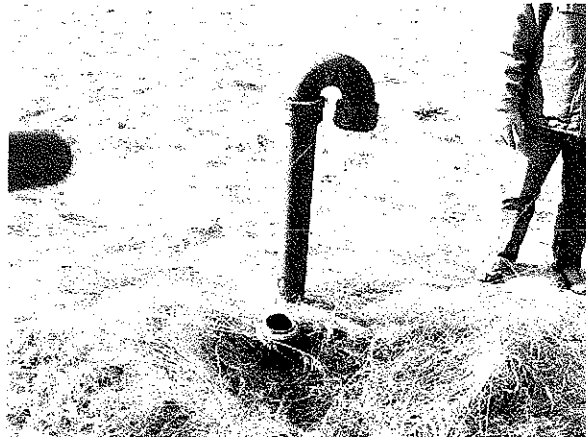
A vent on one of the filtration beds has been damaged see Photo 80.

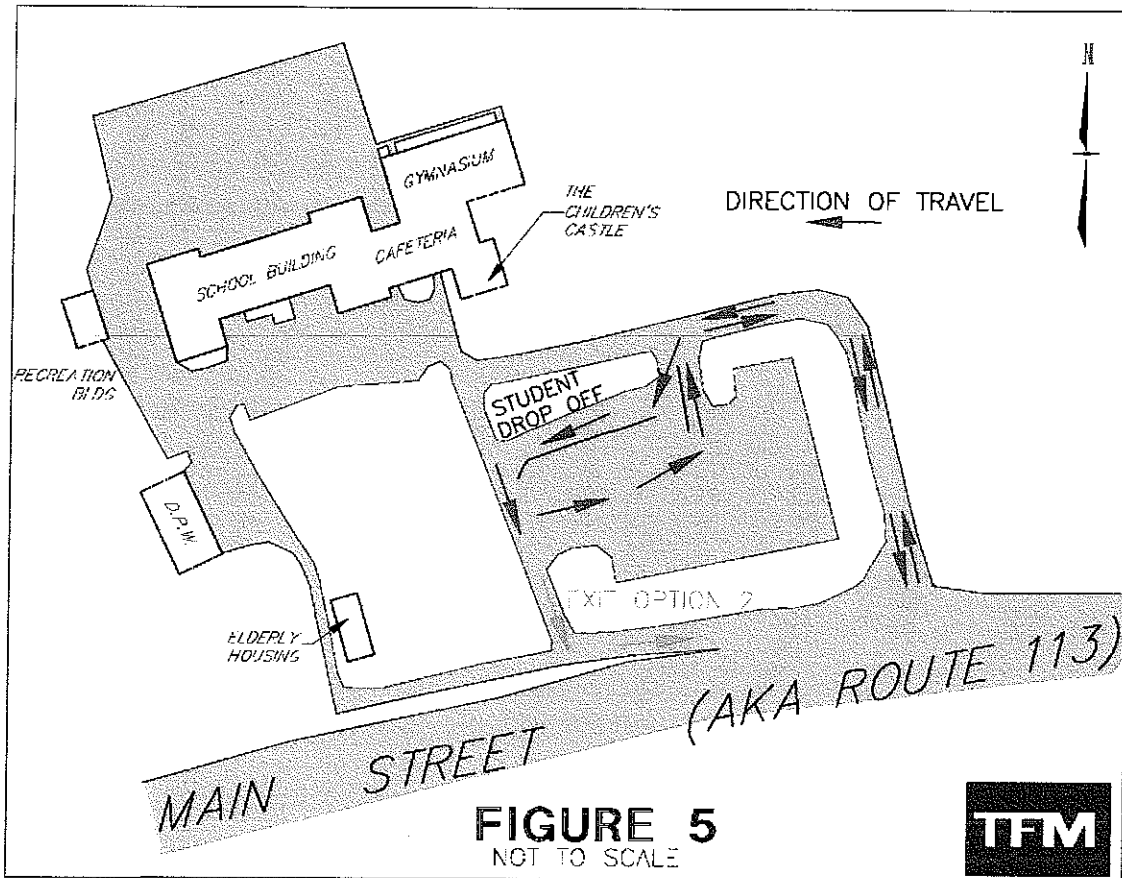
The third is by parking in a marked space, whether for the entire school day or a short time. All parking is located off of the main access drive. The lower parking lot is the largest lot, which is used by the majority of the faculty and The Children's Castle operation. It is TFM's understandings are that The Children's Castle parent's park in the lower lot and walk the children into the facility. Other faculty and people with disabilities utilize additional parking in the upper lot in front of the school. No other parking spaces were observed. See Figure 6.

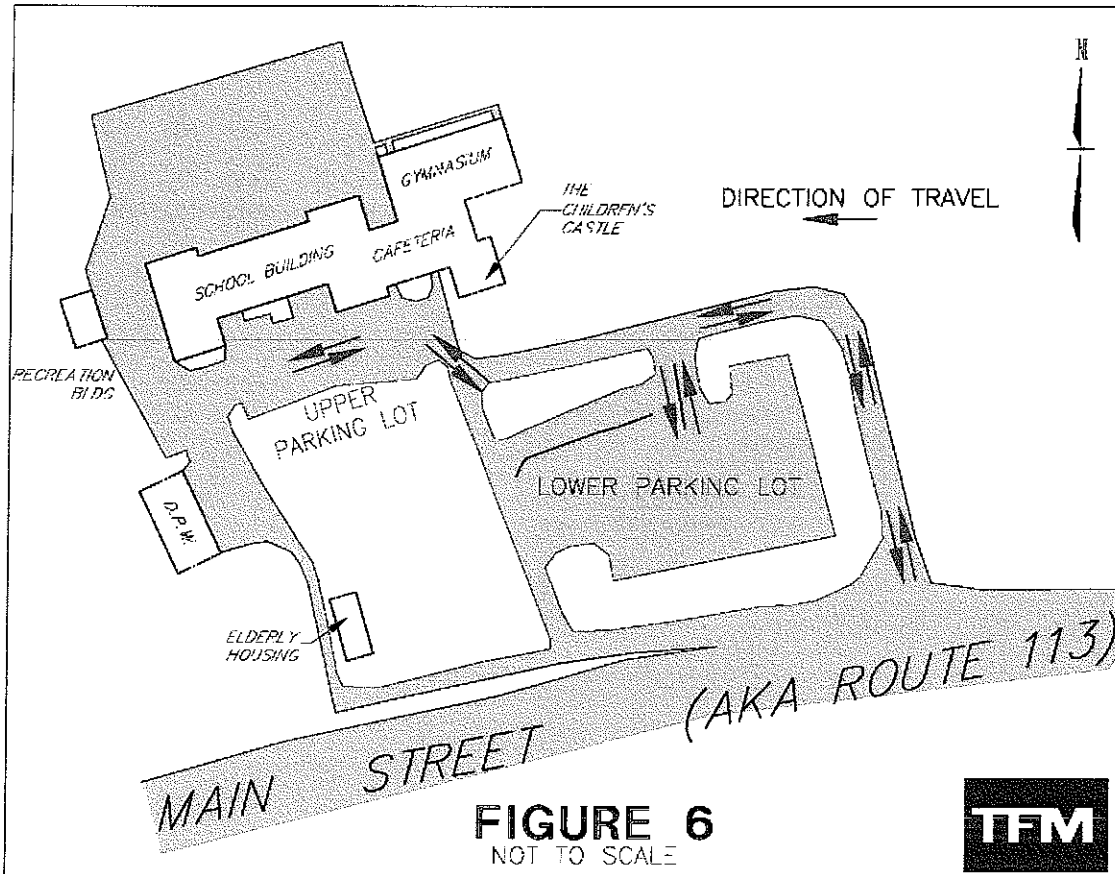
### Pedestrian Circulation

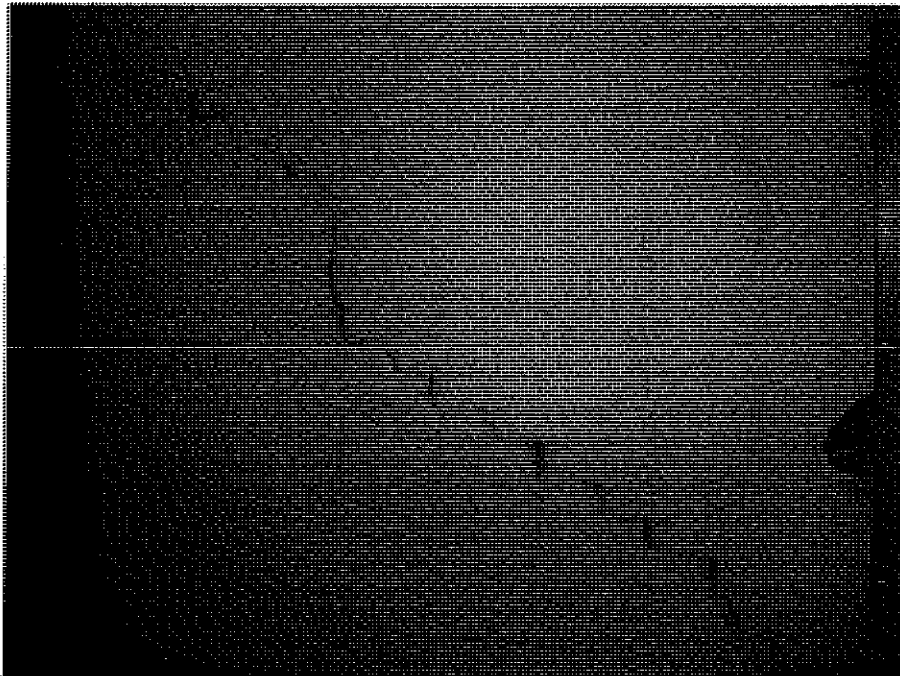
**Photograph 2: Example of masonry cracks in interior walls.**

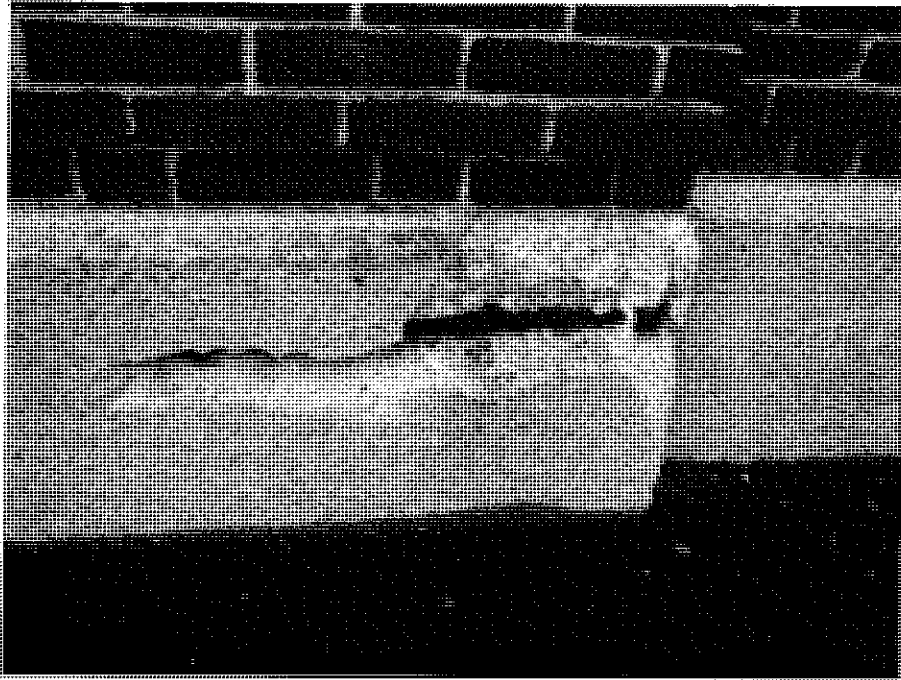
**Photograph 3: Example of spalled concrete at the foundation walls.**

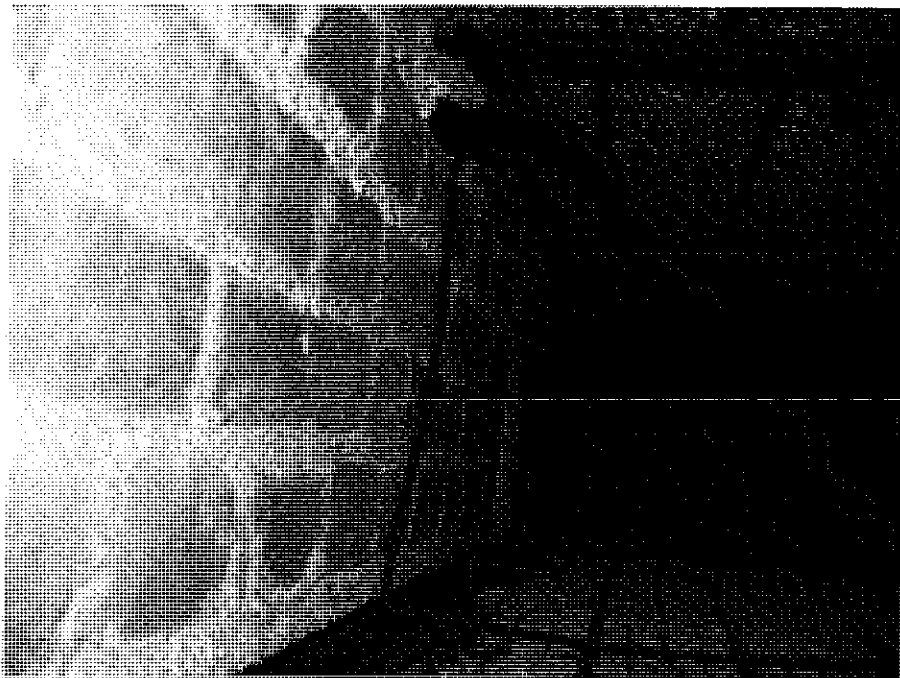
**Photograph 4: Example of joist bearing on exterior masonry walls.**

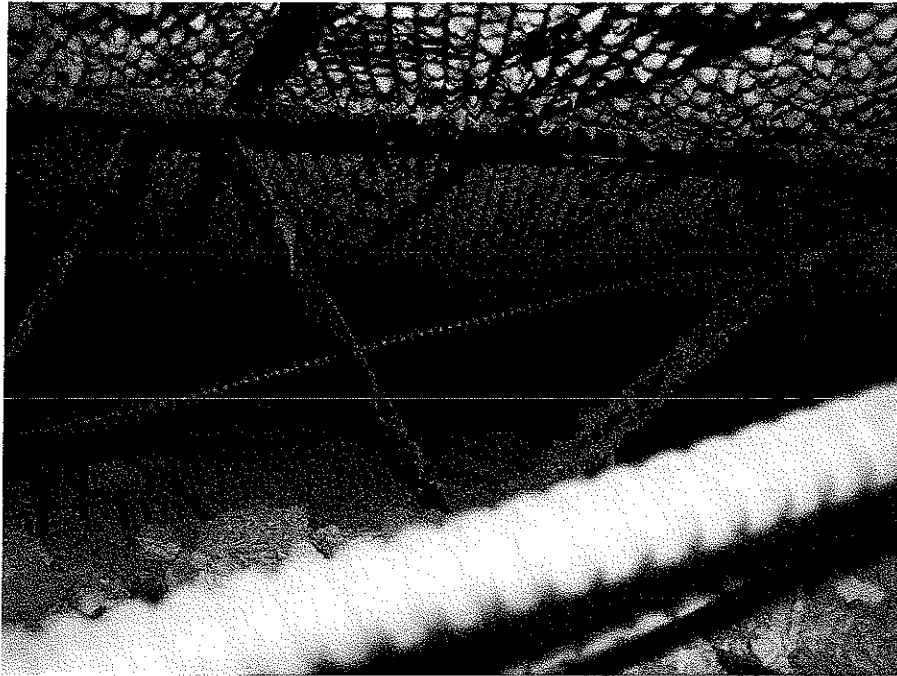
**Photograph 6: Example of sagging gypsum at locations with inadequate connection of wire mesh to joists.**

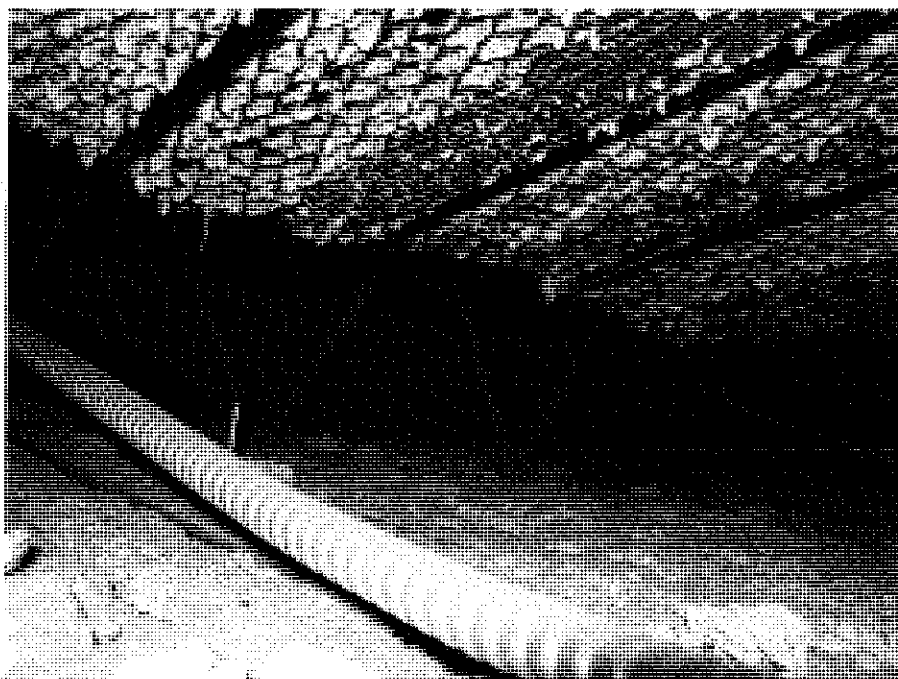
**Photograph 7: Example of slab failure and subsequent repairs at the time of original construction.**

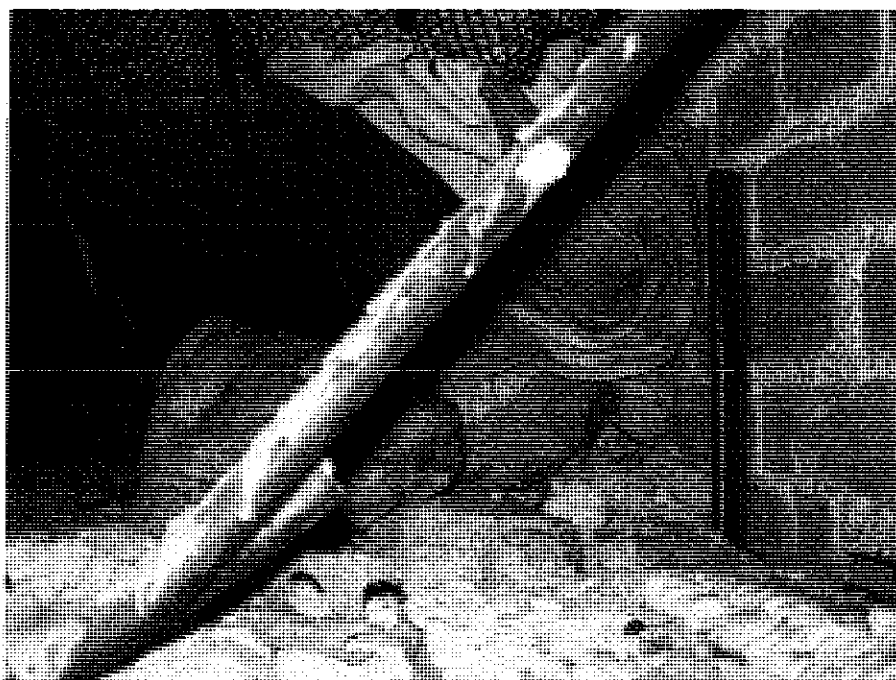
**Photograph 8: Example of slab failure and subsequent repairs at the time of original construction.**

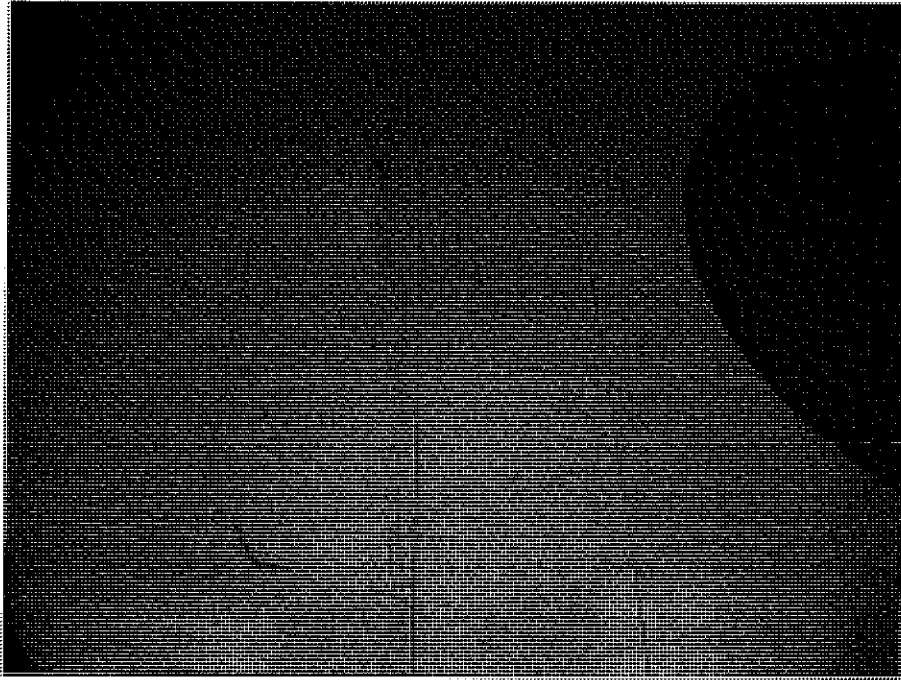
**Photograph 9: Cracks through floor finishes in classroom above the boiler room.**

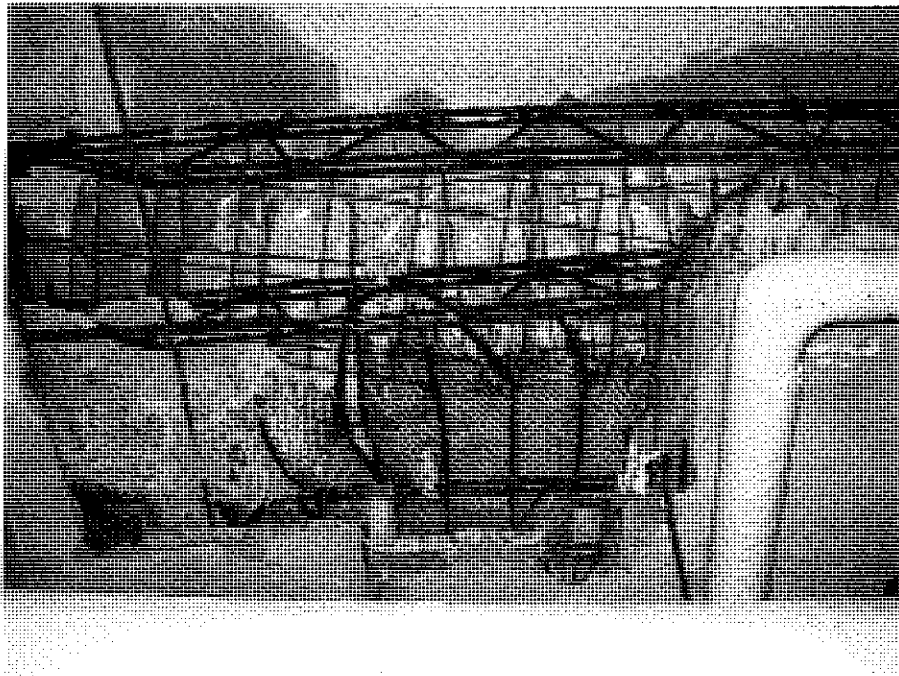
**Photograph 10: Example of inadequate repairs to floor slab above the boiler room.**

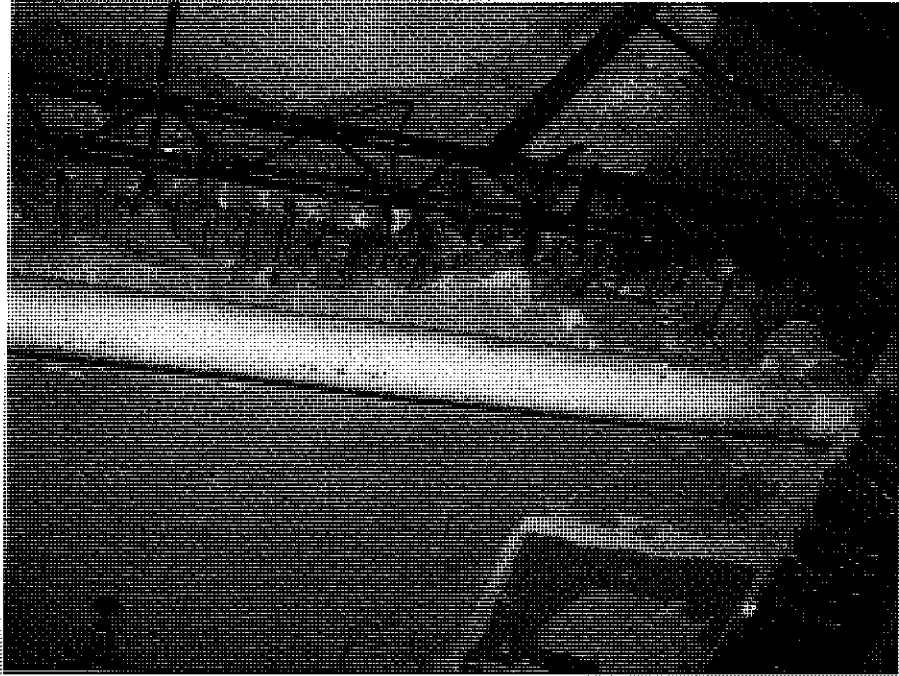
**Photograph 11: Example of inadequate repairs to floor slab above the boiler room.**

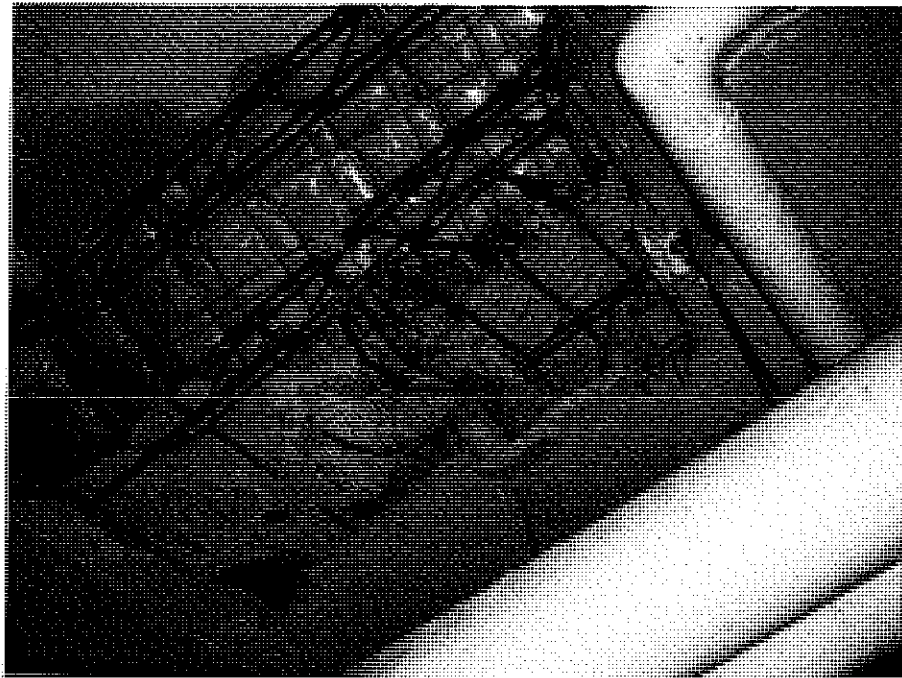
**Photograph 12: Example of inadequate repairs to floor slab above the boiler room.**

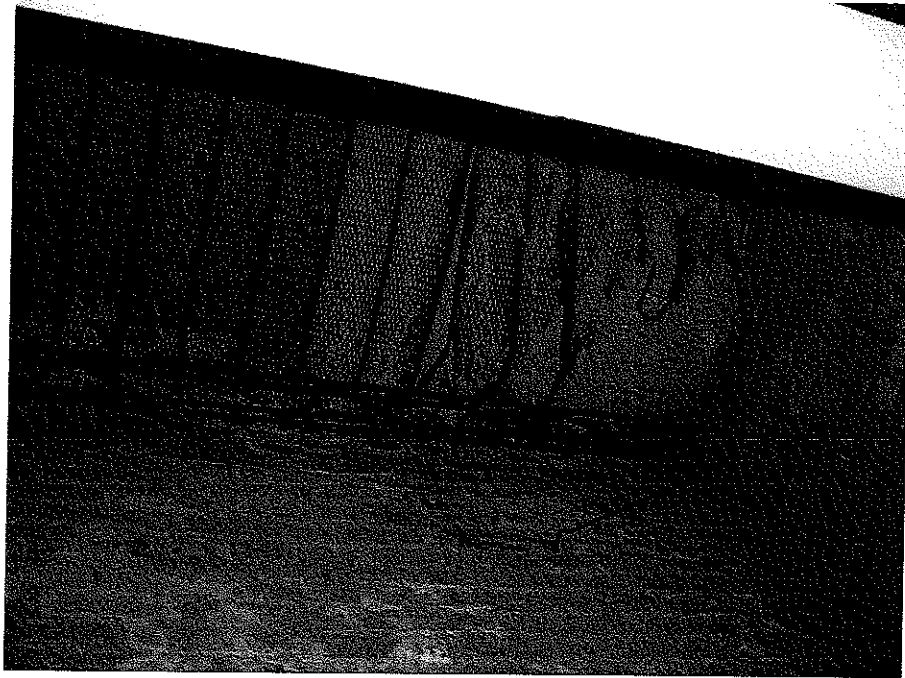
**Photograph 13: Example of inadequate repairs to floor slab above the boiler room.**

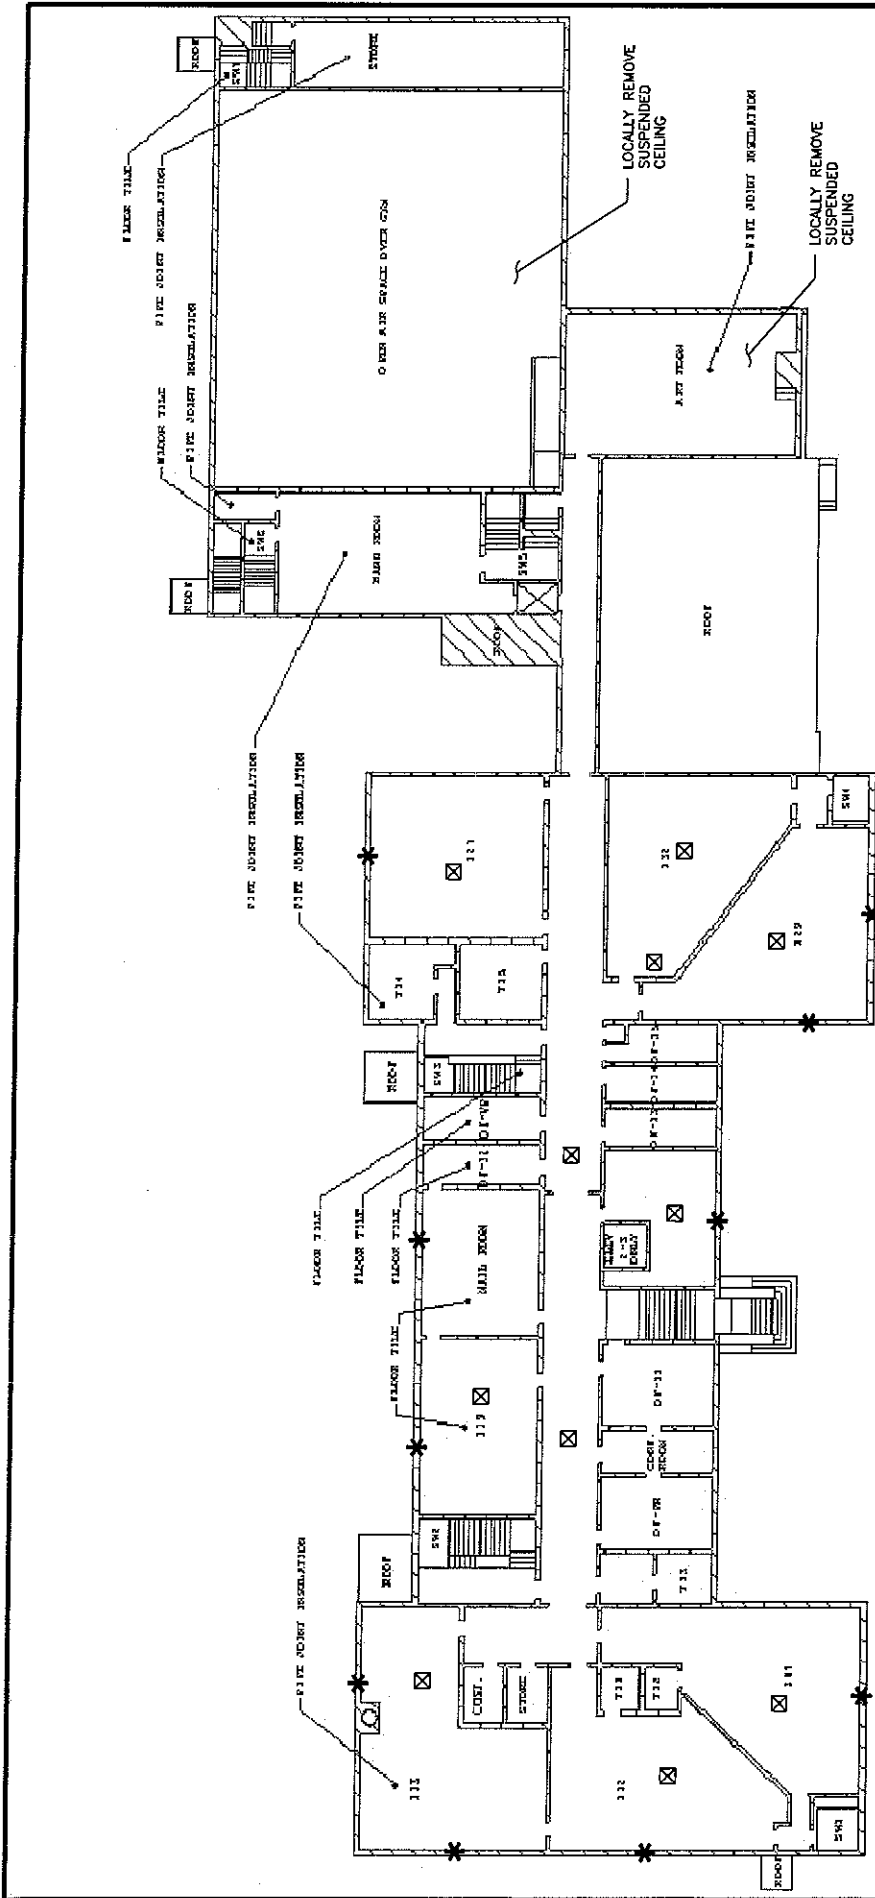
X INDICATES LOCATIONS OF LOCALIZED CEILING REMOVAL ABOVE.  
 \* INDICATES EXPOSE STEEL JOISTS OR BEAM AT MASONRY BEARING.
