# Facilities Assessment STUDY

Dr. John C. Page Elementary School

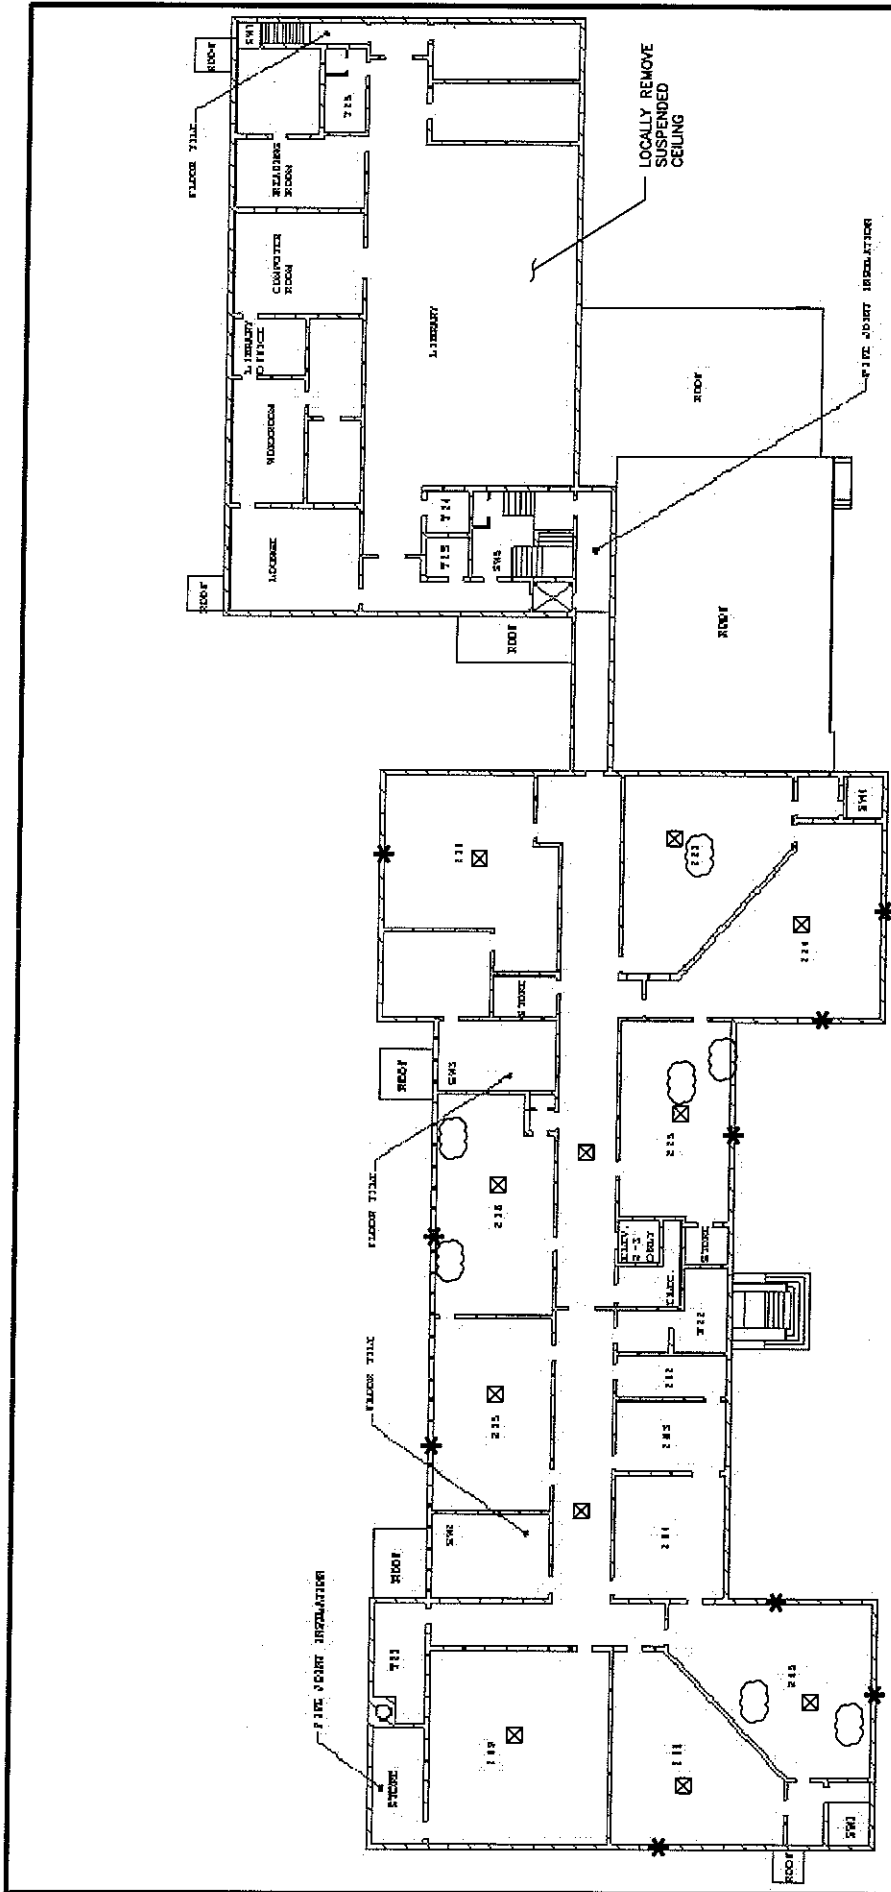
- ☒ INDICATES LOCATIONS OF LOCALIZED CEILING REMOVAL ABOVE.
- \* INDICATES EXPOSE STEEL JOISTS OR BEAM AT MASONRY BEARING.
- ☁ INDICATES AREAS OBSERVED THAT WERE DAMAGED AND SUBSEQUENTLY REPAIRED AT TIME OF ORIGINAL CONSTRUCTION

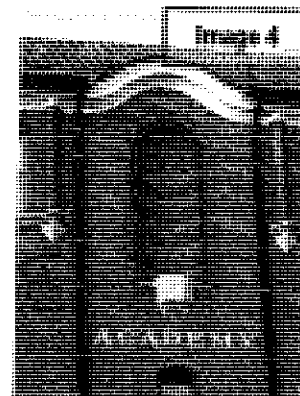
necessary to find a long term solution to create moisture barrier and possibly improve the thermal performance of these walls.

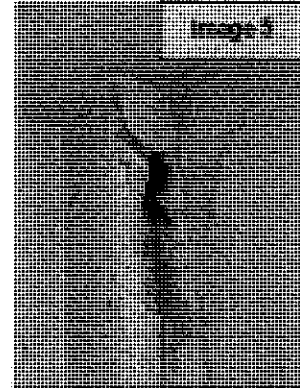
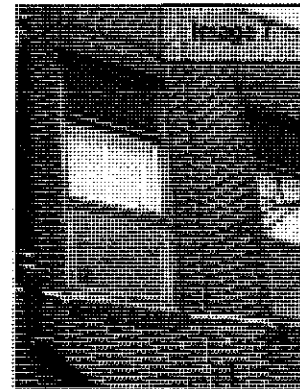
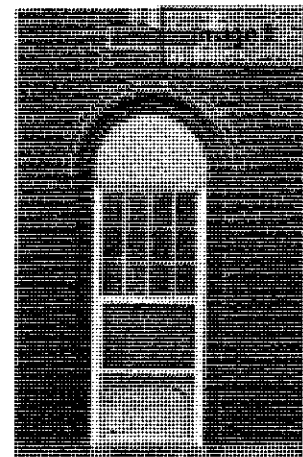
7 & 8). This solution fit into the design of the renovations, but it has significantly reduced the amount of natural light in the building

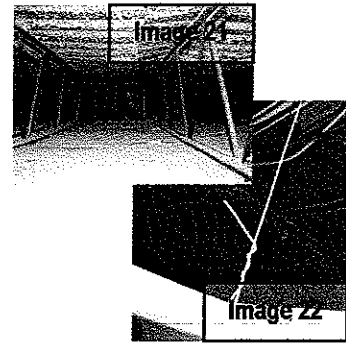
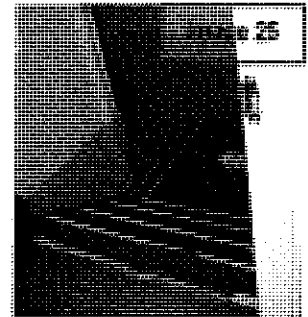
debris and dry water from shoes prior to climbing of the stair, recommendation is to have 30 feet of matting at any primary entry to a public building.

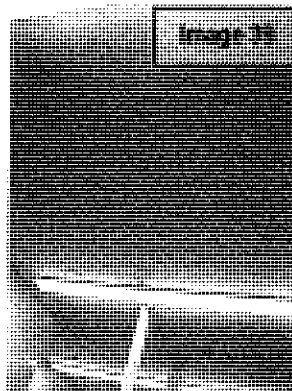
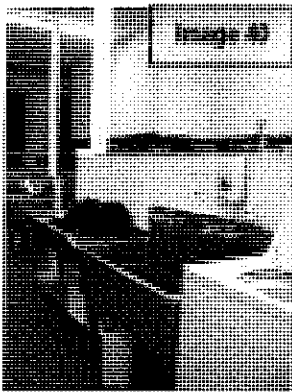
maintained (images 40 & 41). According to the staff some of the cooking equipment has been recently updated, and one of the kettles is a steam kettle which is run directly from one of the boilers (image 41).

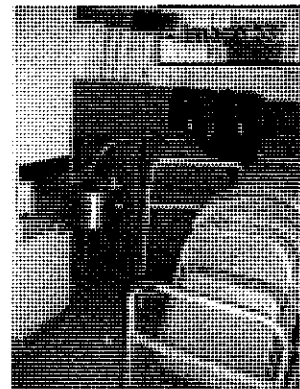
in addition daily to school use. There are multi-fixture toilet rooms adjacent to the gym and an abandoned shower room which is used for chair storage (image 53) As noted above, the music risers can be moved from one of the music rooms to the gymnasium creating an opportunity for performance, there is no stage or platform in the building.

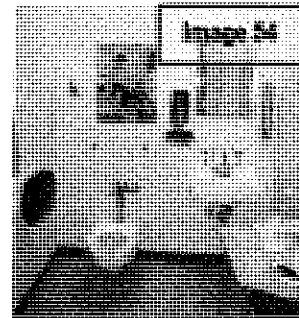
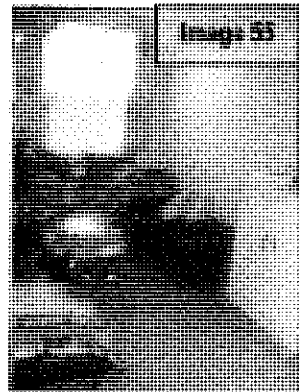
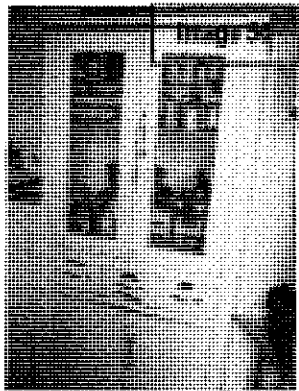
oldest (grade 6) on the third floor. All but three of the classrooms have a sink and counter area.

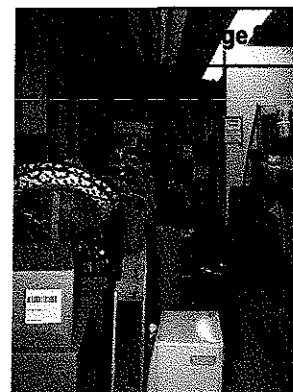
## Handicap Accessibility

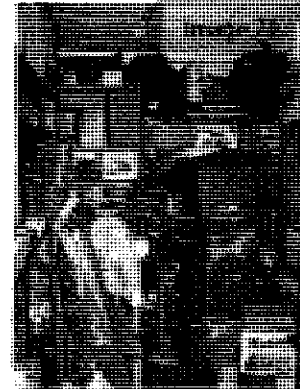
4. Most doors in the building appear to provide the required width however there were isolated instances such as the corridor access to the sprinkler pump room, which did not meet the required 32" clear space. This space has another entry point and is accessed by a spiral stair (image 78). This particular door should be locked and labeled for the safety of all users. There are also a few instances where doors are not provided with any notable clearance on the latch side of the door. Current regulations require minimums of 12" on the push side and 18" on the pull side of the door for operation from a

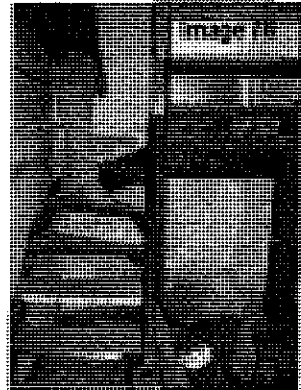
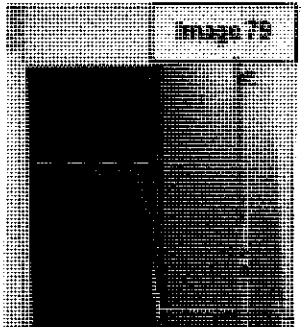
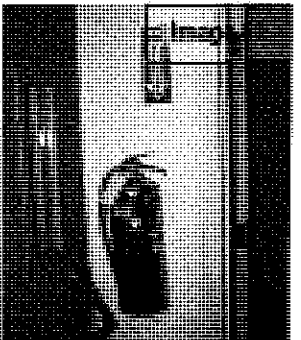
5. Lighted exit signs were observed throughout the building with noted exceptions in the boiler room where one was missing and misplaced exit notations on communicating doors and folding partition openings between classrooms (image 79). Any situation on which an exit sign is misplaced or none is evident along a path of egress creates a potential hazard to all users of the facility, and should be addressed as soon as possible. See the electrical portion of this report for more information.

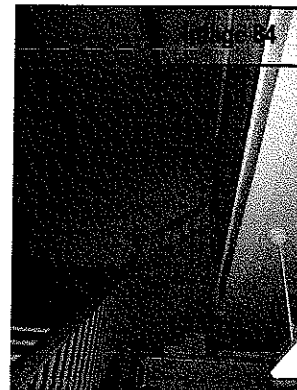
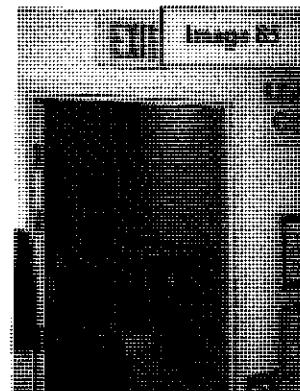
second means of egress, however the doors and exit signage does not meet the regulations noted above. The large classrooms on the northeast and northwest corners of the building have only one means of egress and again the doors and exist signage do not comply with current code.

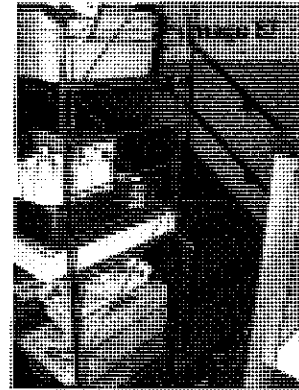
## Conclusions and Recommendations

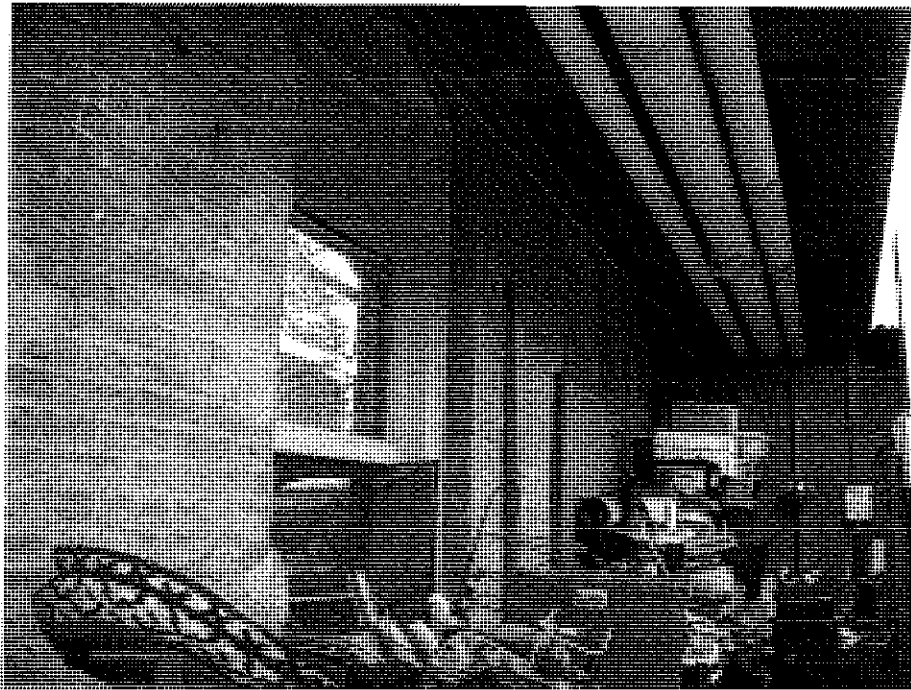
## HAZARDOUS MATERIALS ASSESSMENT

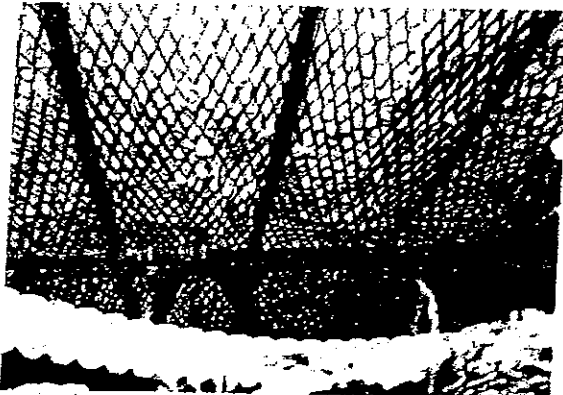
Figure 1: Typical underside of hallway  
3-007 Page School\_ West Newbury

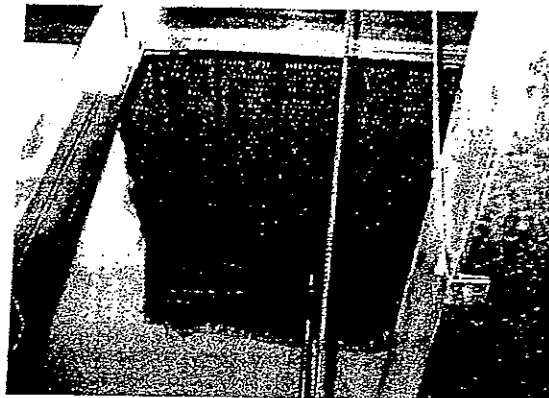
Figure 2: Typical underside of 2<sup>nd</sup> floor classroom

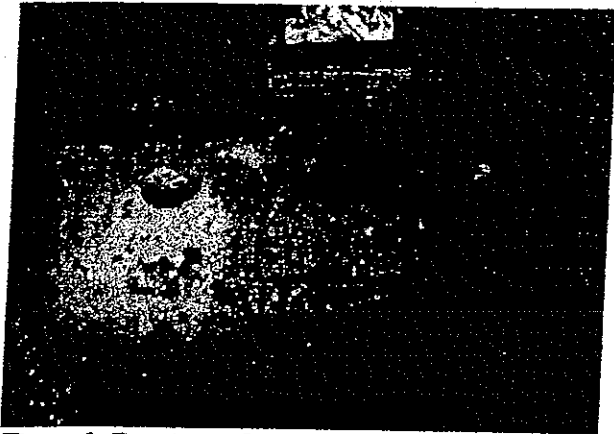
Figure 3: Deteriorated area - overall

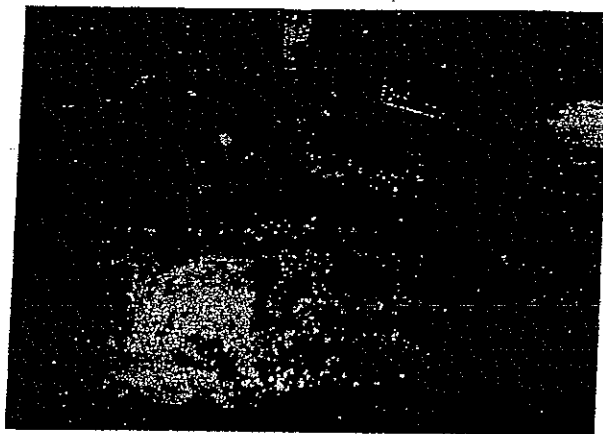
Figure 4: Deteriorated area w/stairway door location

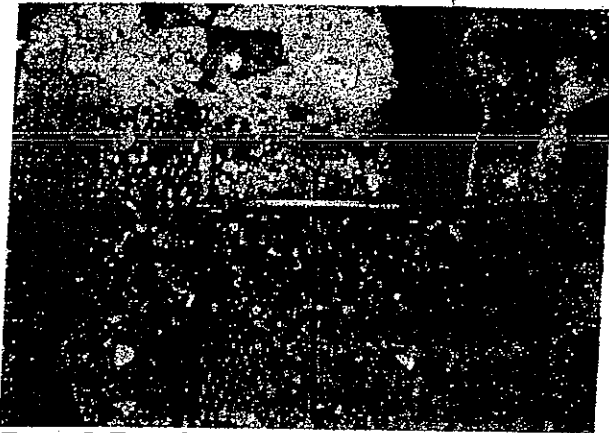
Figure 5: Typical expanded wire mesh rib spacing

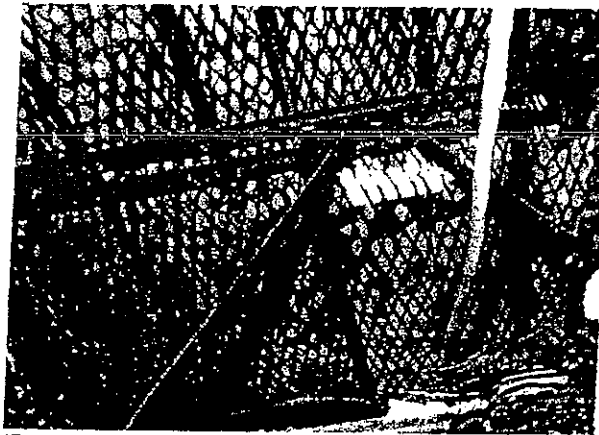
Figure 6: Existing patch of boy's bathroom floor

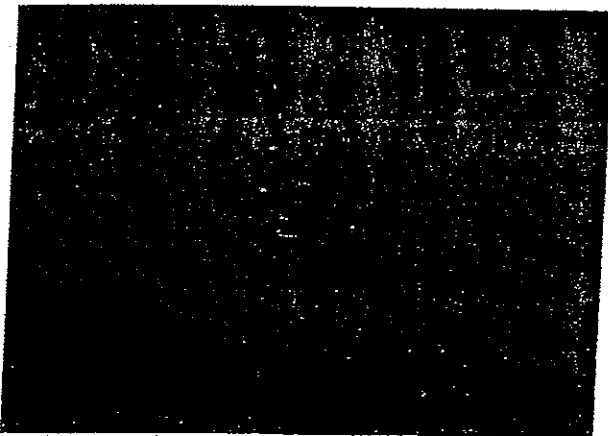
Figure 7: Typical bathroom floor

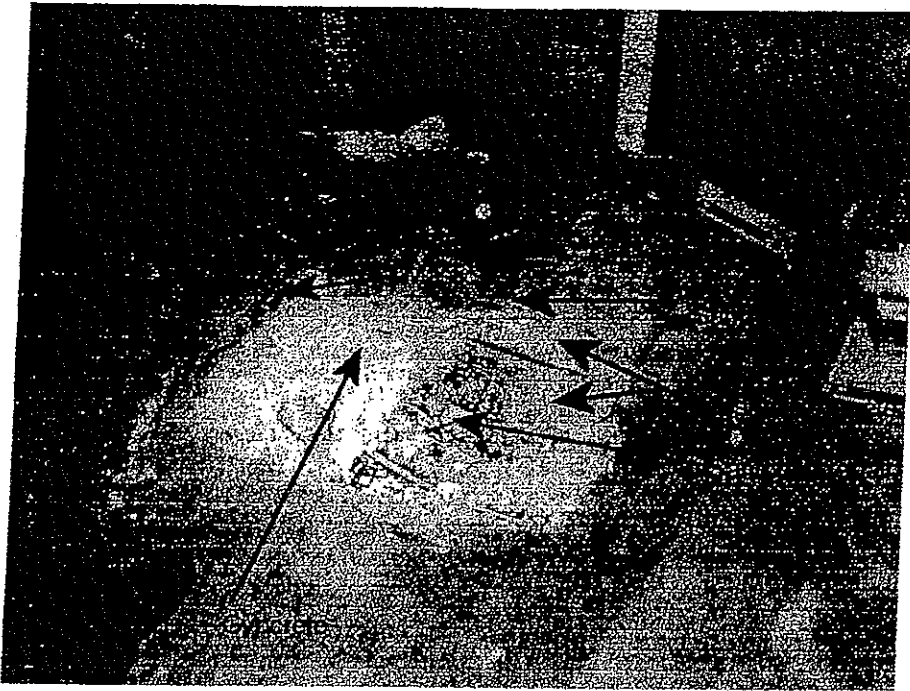
Figure 1. Illustrated photograph of damaged portion of second floor at Page School, West Newbury, MA. Note area of historic repair using gypsum sand bed, and more recent repair using Gypcrete.

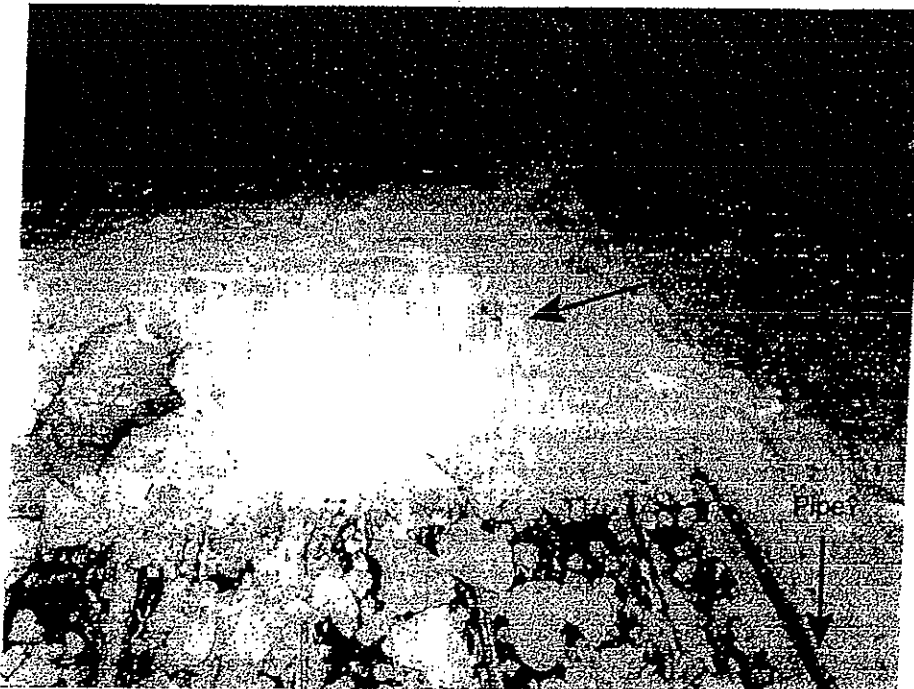
Figure 2. Illustrated photograph of damaged portion of second floor at Page School, West Newbury, MA. Note cracks in gypsum concrete and gypsum sand bed adjacent to Gypcrete repair. Also note pipe (?) avoided during sampling.

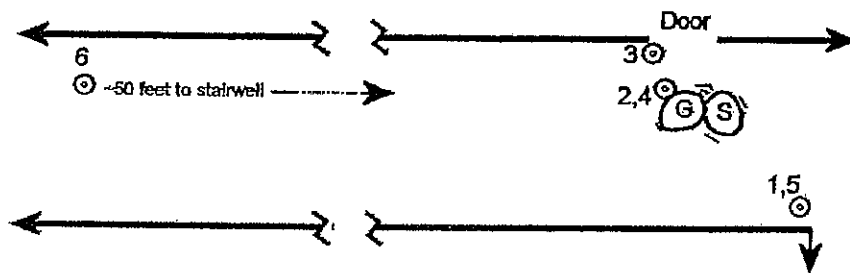
Figure 3. Sketch of damaged second floor hall outside of stairwell, Dr. John C. Page School, 694 Main St., West Newbury, MA showing locations of concrete core samples (#'s 1 - 6) and areas where the historic sand-bed (S) and more recent Gypcrete (G) floor repair materials were exposed. Not drawn to scale.

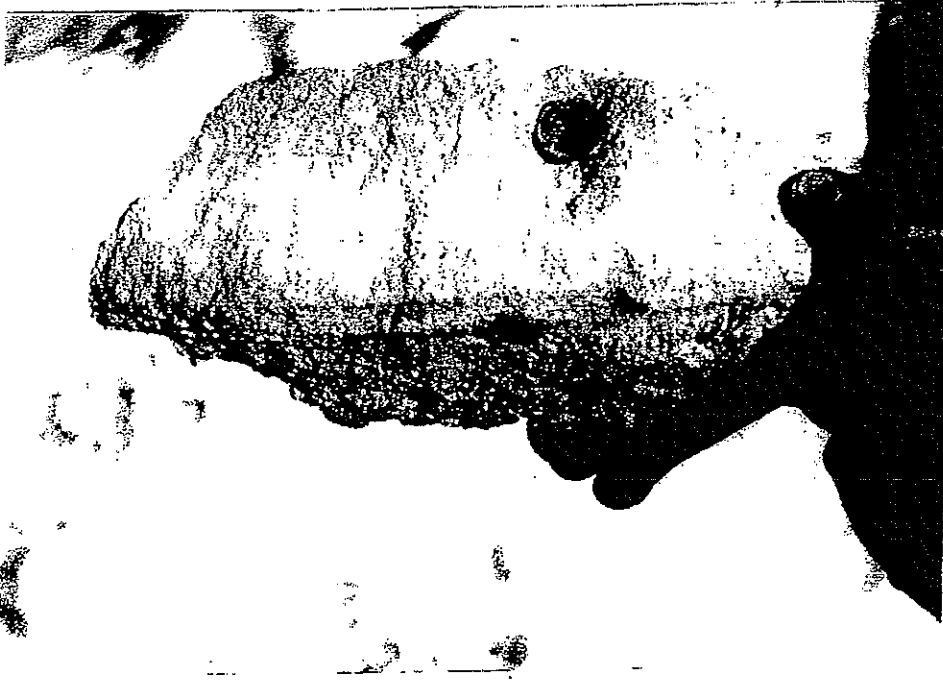
Figure 4. Photograph showing gypsum sand bed on rubble of gypsum gravel concrete in specimen removed from floor. The gypsum sand bed was used to fill an incompletely cleaned hole in gypsum gravel concrete during its first historic repair. Coin for scale.

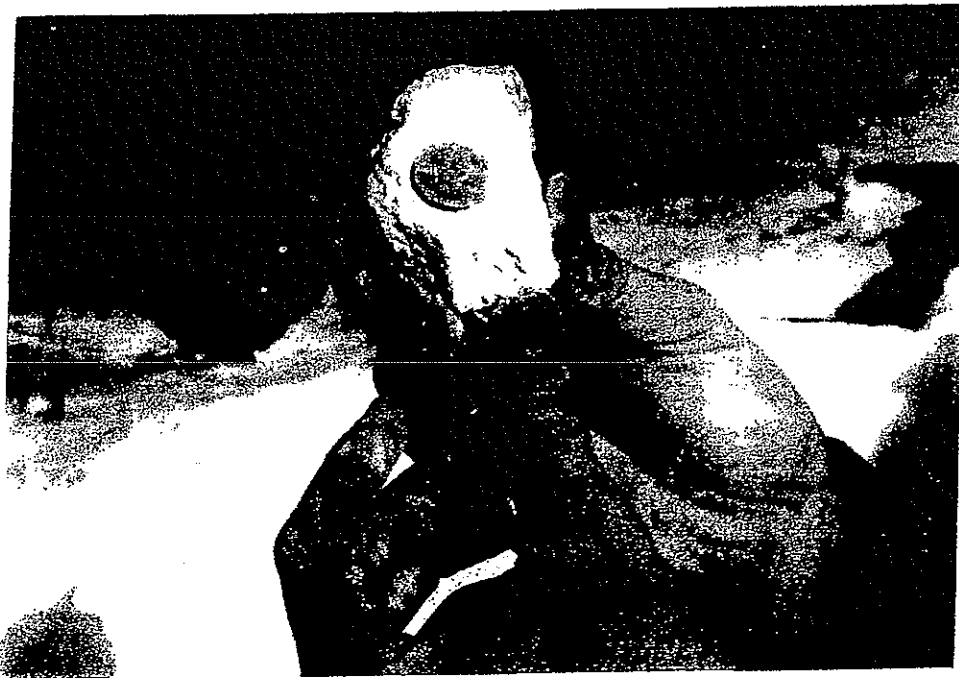
Figure 5: Photograph of piece of Gypcrete used in second more recent repair of the gypsum gravel concrete floor. Coin for scale.

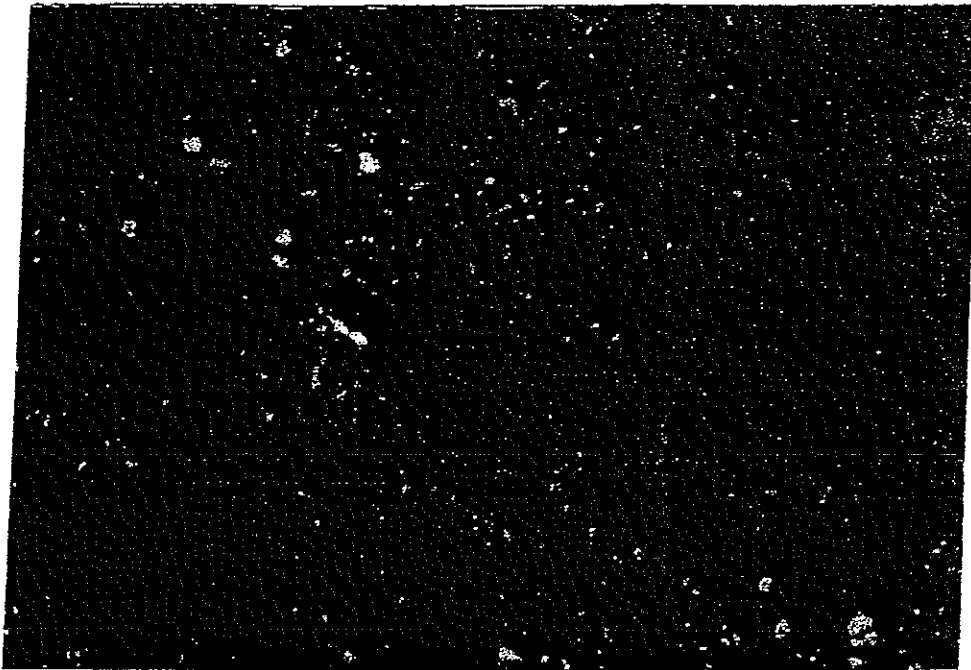
Figure 6. Photomicrograph of gypsum cement binder from Core 3. Note that the gypsum cement occurs as a fine grained matrix and also as coarser, recrystallized material partially or wholly filling void spaces. Crossed Nicols. Gypsum Plate. Field width = 1.4 mm.

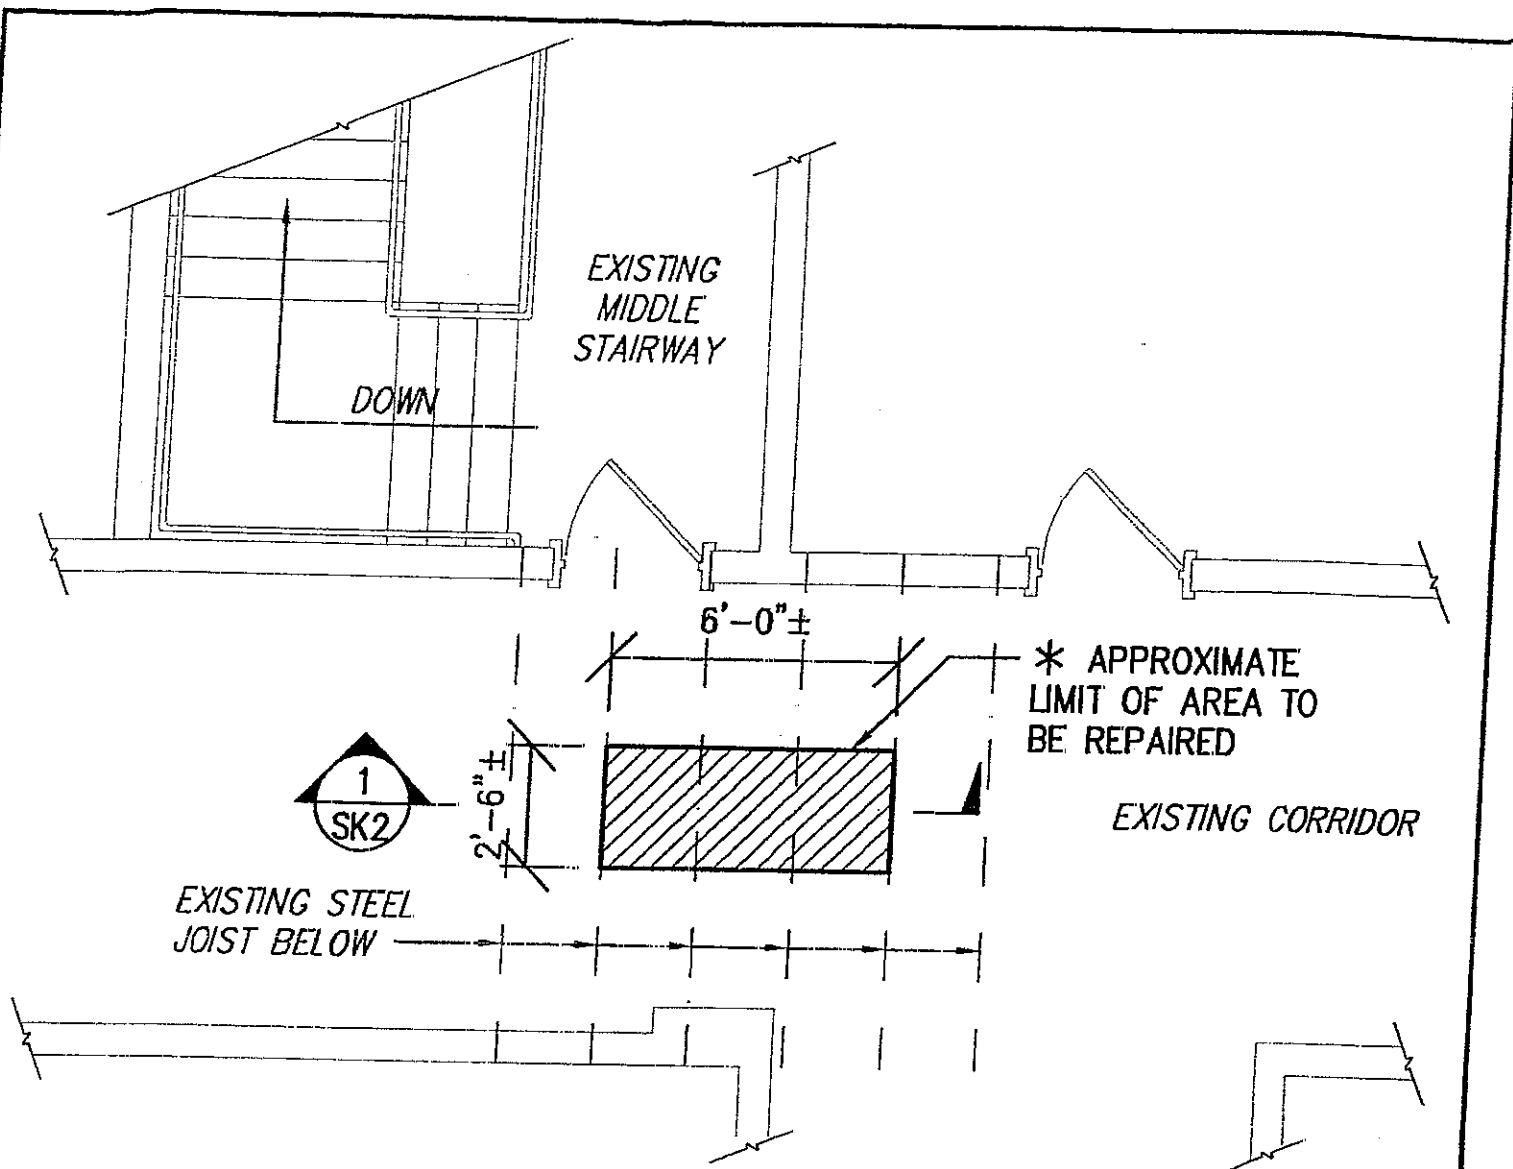
ALL CONCRETE WORK SHALL CONFORM TO THE "BUILDING CODE REQUIREMENTS FOR REINFORCED CONCRETE (ACI 318-02)" AND "SPECIFICATIONS FOR STRUCTURAL CONCRETE FOR BUILDINGS" (ACI 301).

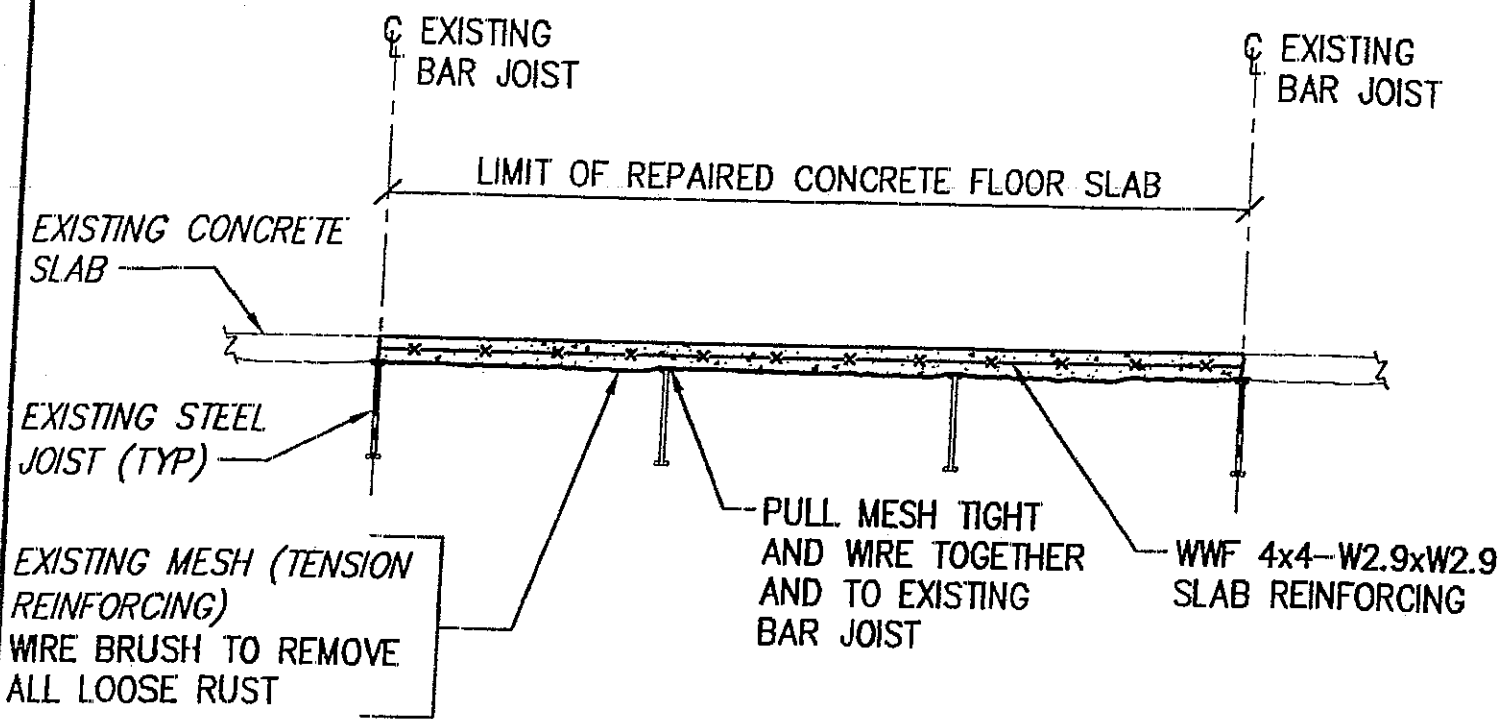
1 SECTION REPAIR OF CONCRETE FLOOR SLAB  
 SK1 SCALE: 3/4" = 1'-0"
