SUBJECT: BRIDGE INSPECTION REPORT (NON-NBIS)

N-11-007=W-20-001 (8BC) Plummer Spring Road / Artichoke River C/RI Dated: 6/27/19

STRUCTURES INSPECTION FIELD REPORT
CLOSED/REHABILITATION INSPECTION

BR. DEPT. NO.
N-11-007=W-20-001

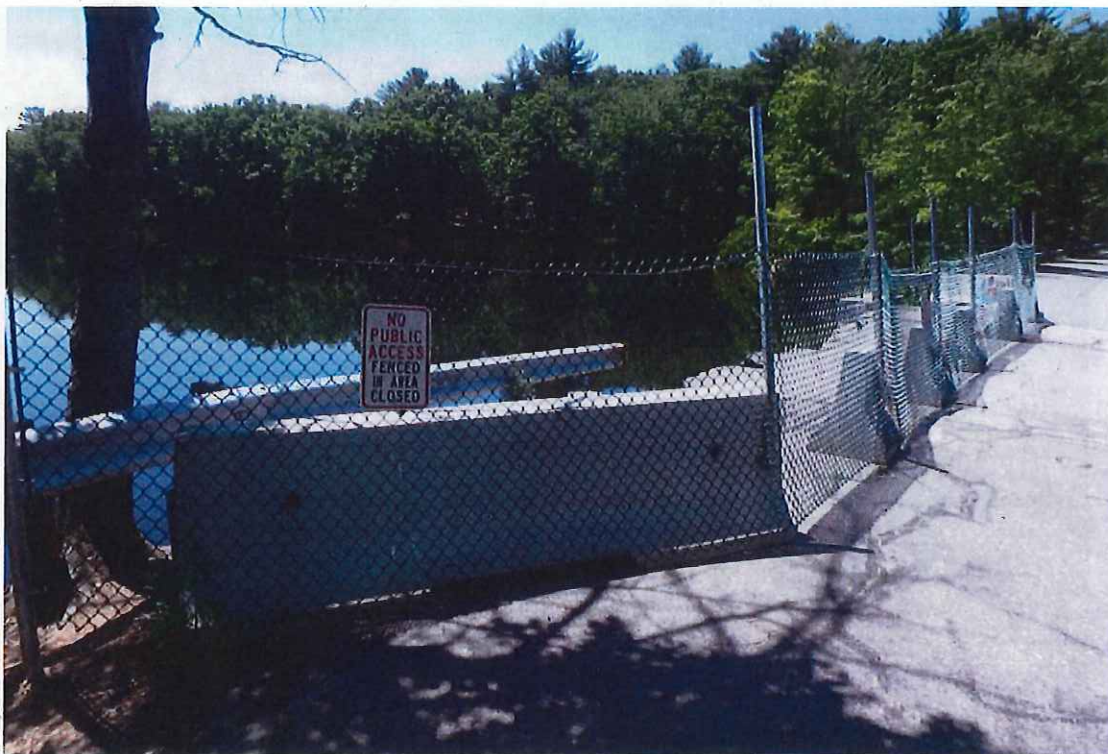
The bridge has been closed to vehicle traffic due to a failure in the spandrel wall at the southeast corner of the bridge. Jersey barriers with 6' high chain link fencing have been placed at the south side of the bridge preventing pedestrians from accessing the collapsed area (see **Photos 1-4**). Road closed and detour signs have been placed at intersections on both sides of the bridge about half a mile away in either direction (see **Photo 5**). Jersey barriers, traffic barrels, and signs are installed between cross streets and bridge warning of closed bridge ahead, but not preventing traffic (see **Photo 6**). Jersey barriers, traffic barrels and road closed signs have been installed at both ends of the bridge preventing vehicle access (see **Photo 7**).

Photo 1: Jersey barriers and chain link fencing is in place to prevent pedestrian access to the failed portion of the bridge.

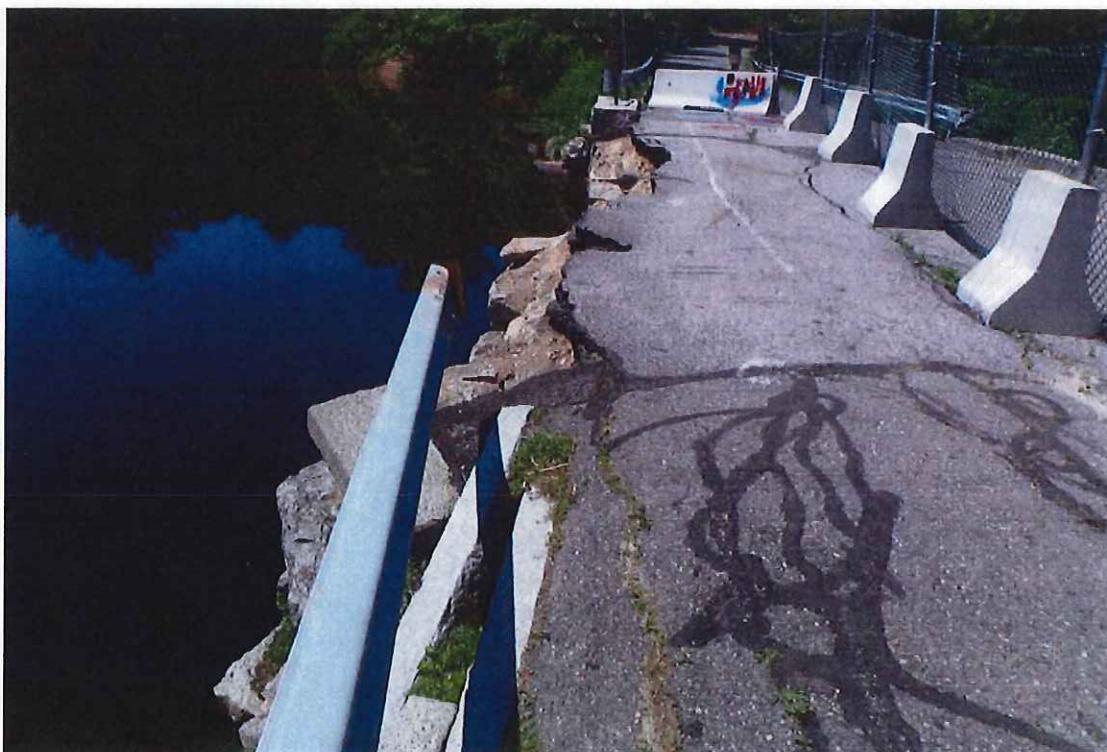
There are signs of additional displacement of material in the collapsed area such as shifting stones, displaced fill material, and displaced and cracked asphalt (see **Photos 2-4**).

Photo 2: Inside the restricted area; spandrel wall has failed and material continues to fall into channel.

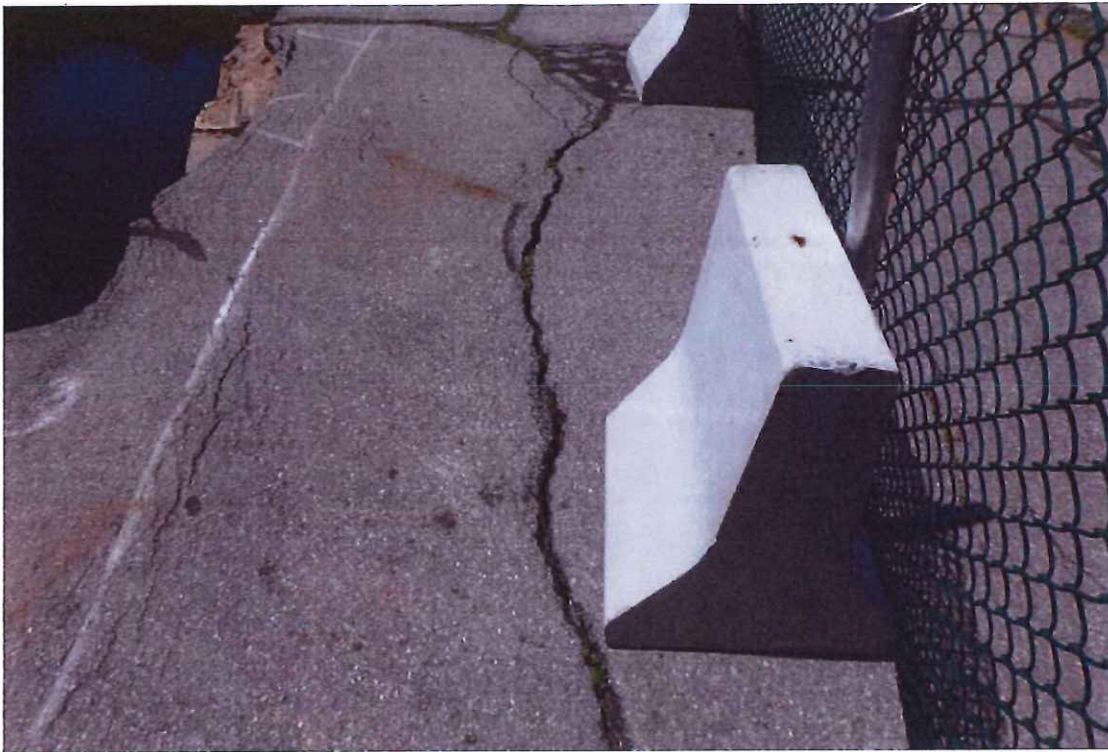
Photo 3: Heavy cracking in the asphalt adjacent to the collapsed area.

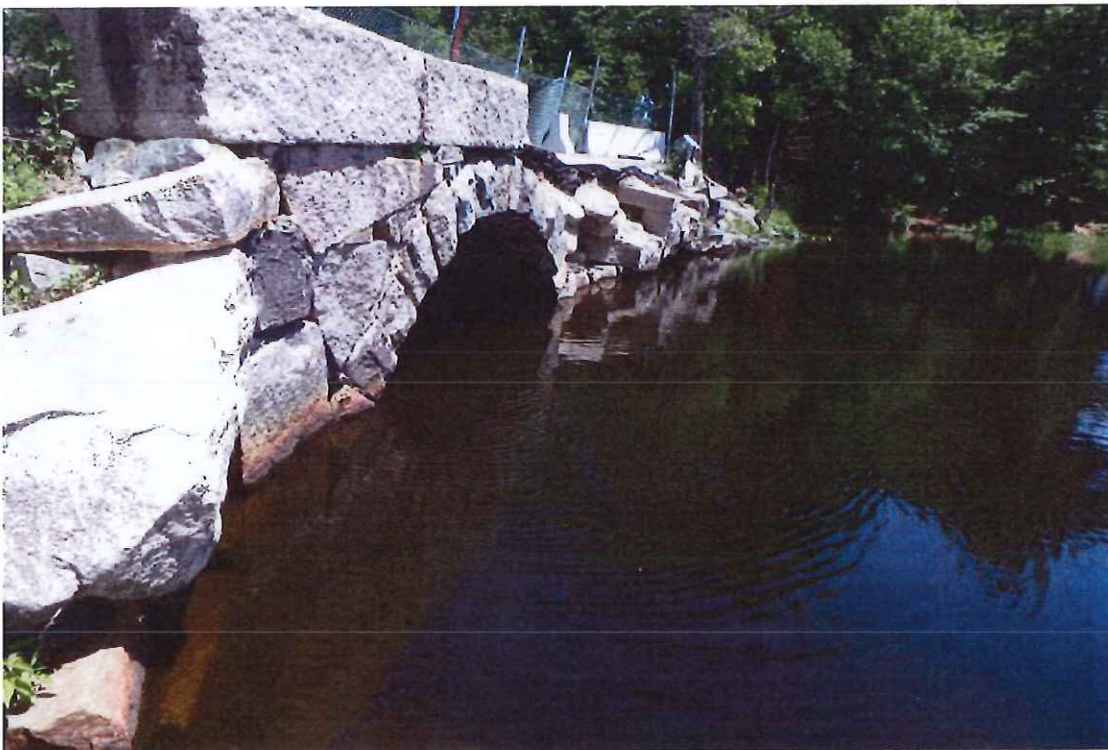
Photo 4: View of the collapsed area from the southwest wingwall. Note the severe displacement of stones on the southeast wingwall area.

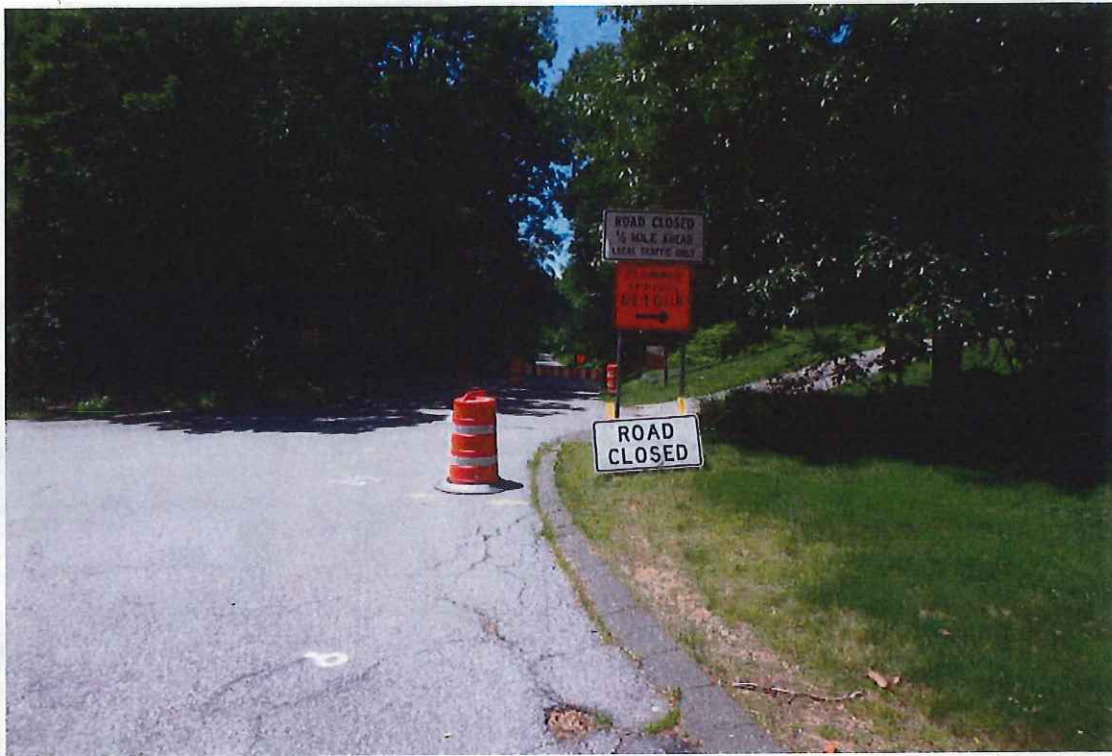
Photo 5: Typical signage at cross streets. Intersection of Turkey Hill Road east of bridge shown.

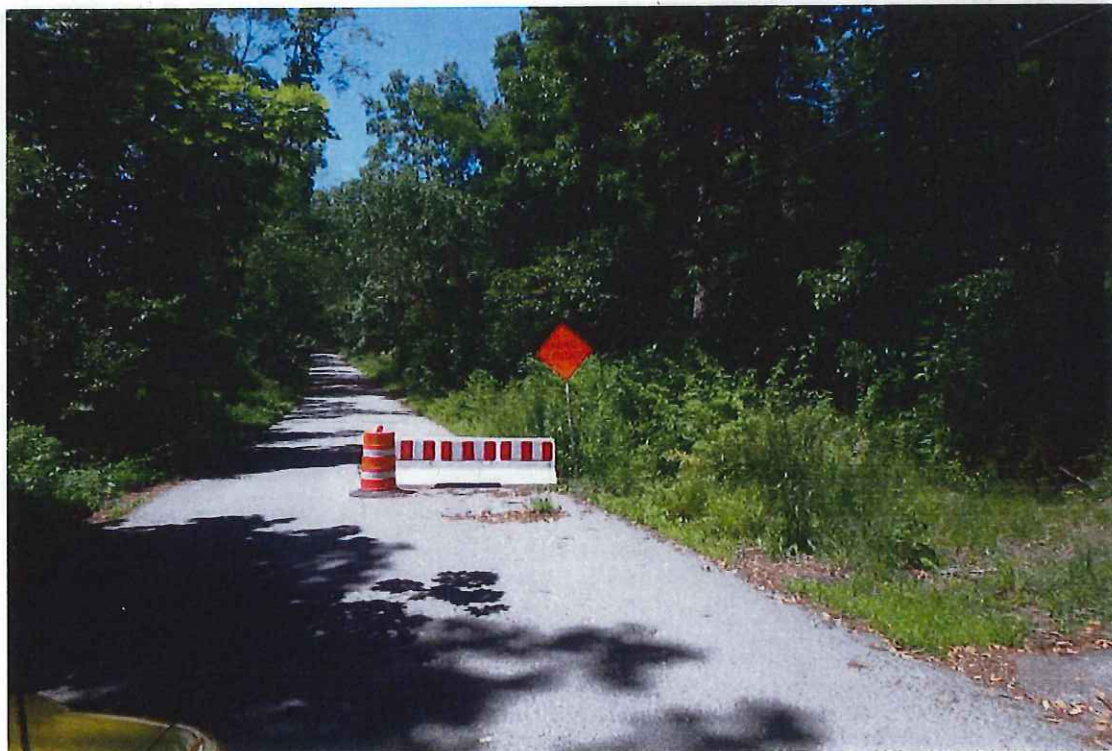
Photo 6: Typical barrier and signage approaching the bridge. East approach shown.

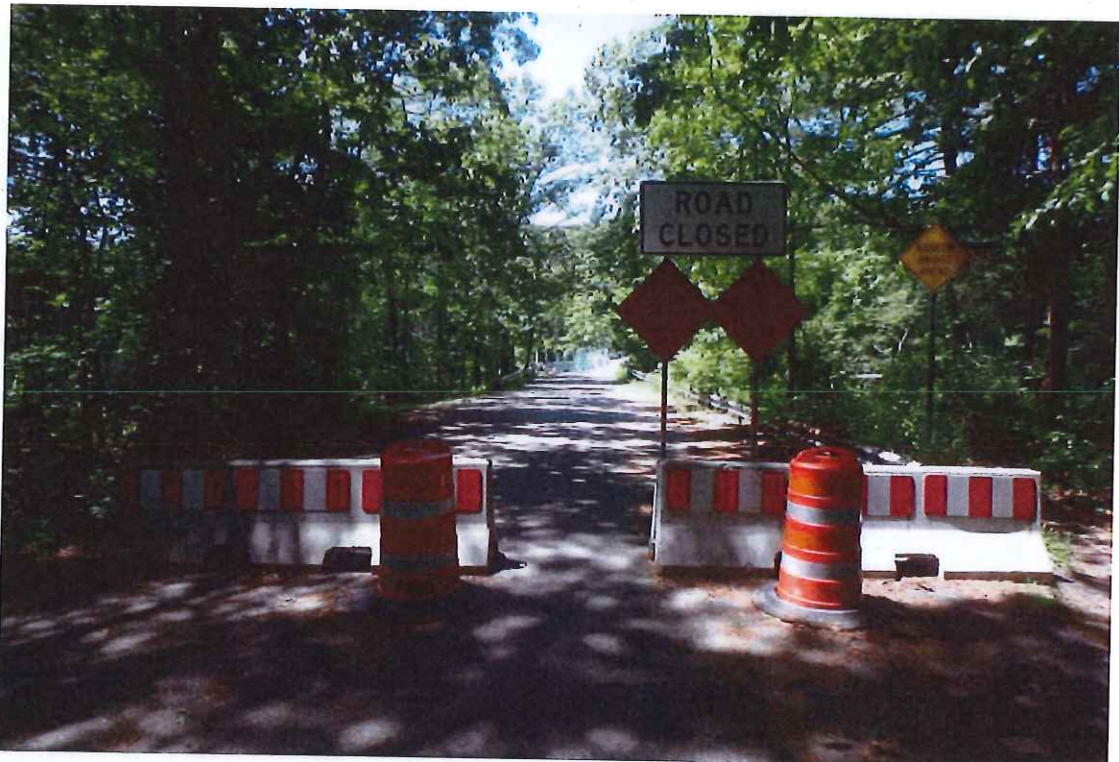
Photo 7: Typical barrier and signage at bridge preventing vehicular traffic. East approach shown.

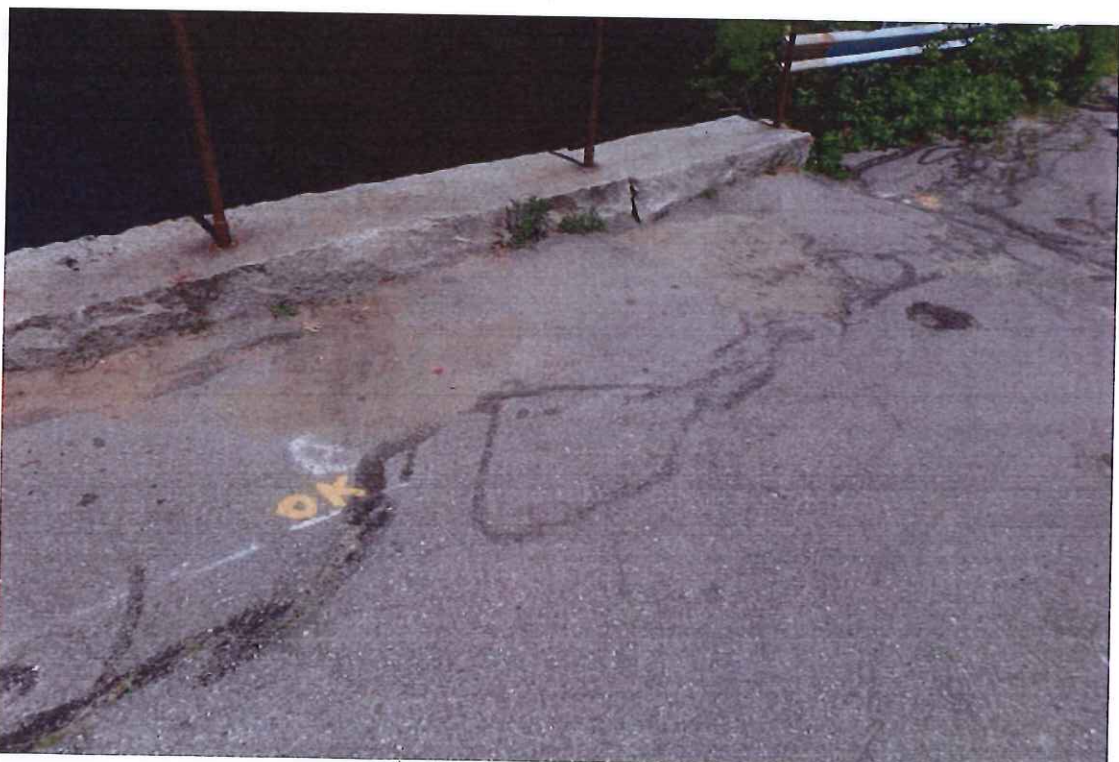
There are signs of additional deterioration on the north side of the bridge (currently open to pedestrian traffic). There are areas of settlement adjacent to the north bridge railing (see **Photo 8**), and bulging of the north spandrel wall (see **Photo 9**).

Photo 8: Settlement areas adjacent to the north bridge railing.

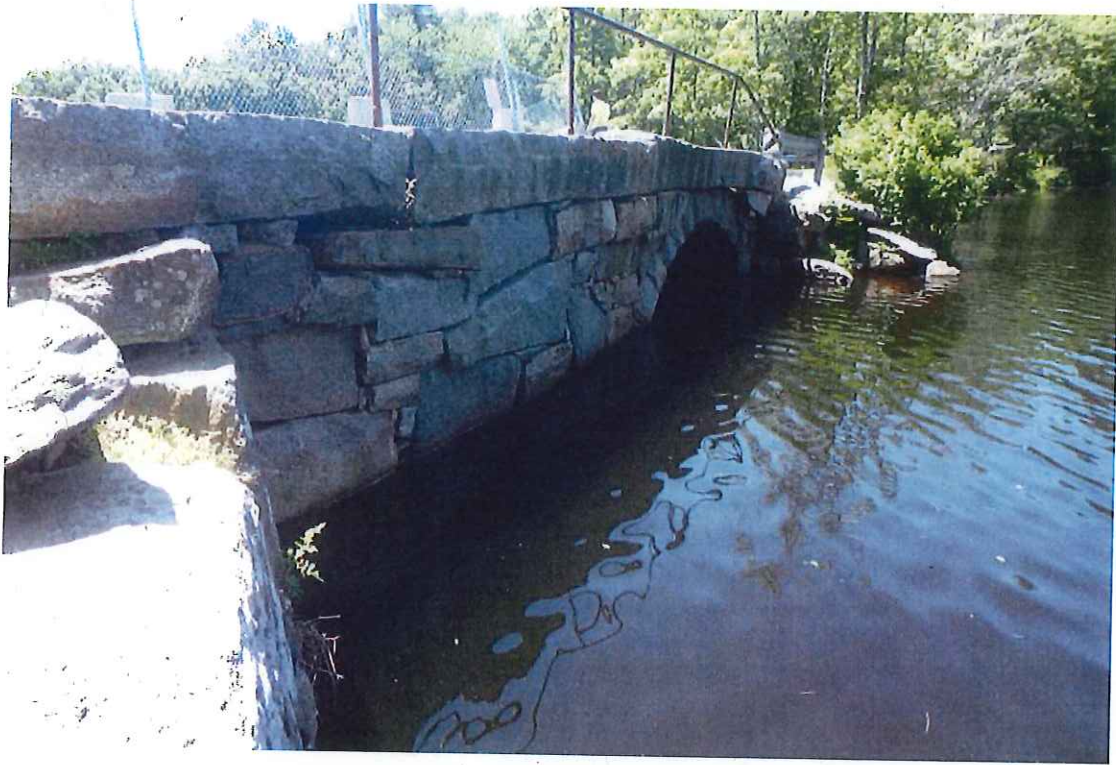
Photo 9: Bulging of the north spandrel wall both east and west of the arch.
