STRUCTURES INSPECTION FIELD REPORT

CLOSED/REHABILITATION INSPECTION

B.I.N.
8BC

Bridge No. N-11-007=W-20-001 (8BC) carries Plummer Springs Road over Artichoke River in the City of Newburyport, Massachusetts. The bridge is oriented West and East and Artichoke River flows from South to North.

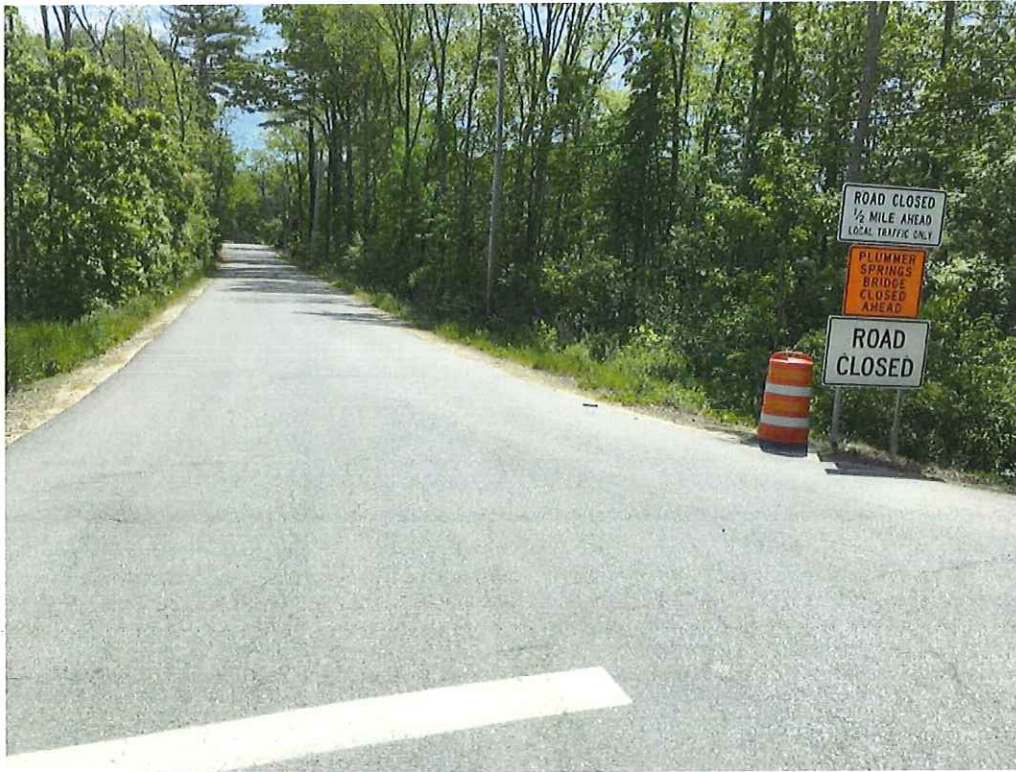
The bridge has been closed to vehicle traffic due to a failure of the south spandrel wall at the east end of the bridge. Advanced "Road Closed" and "Detour" signs have been placed at the intersections and both sides of the bridge. Jersey barriers, traffic barrels, and "Closed Bridge Ahead" signs are installed on both approaches. Jersey barriers, traffic barrels and "Road Closed" signs have been installed at both east and west ends of the bridge preventing vehicle access. **(Photos 1- 8).**

Photo 1: First advanced, "Road Closed Ahead" signs, west of the bridge.

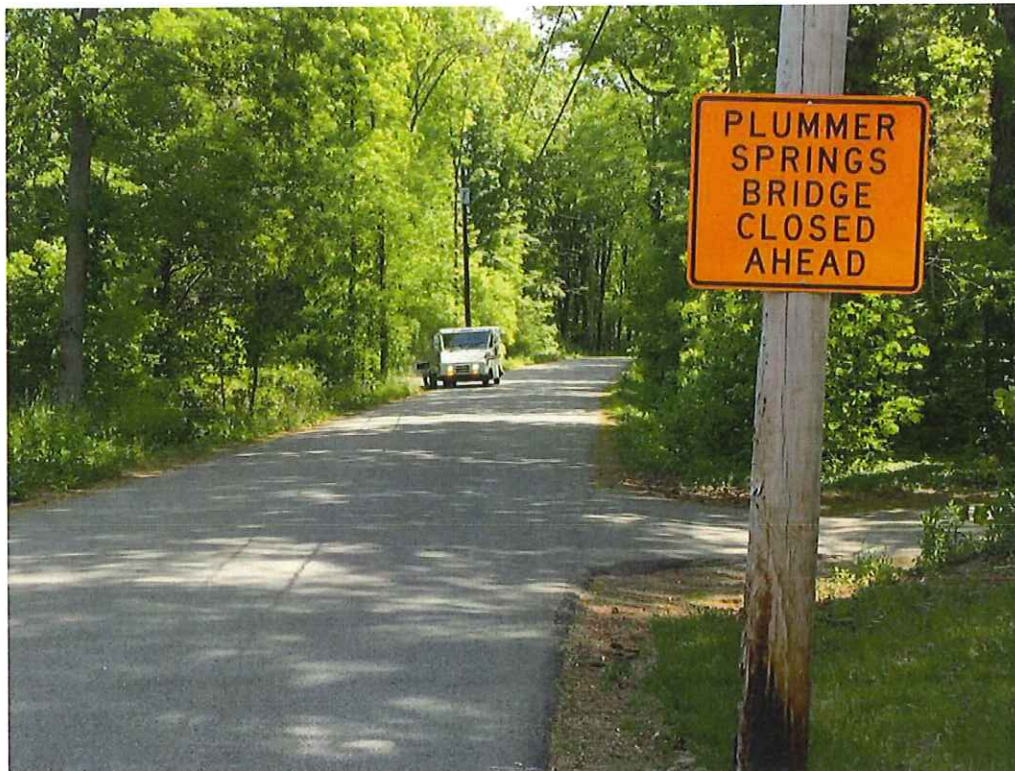
Photo 2: Second advanced, "Bridge Closed Ahead" sign, west of the bridge.

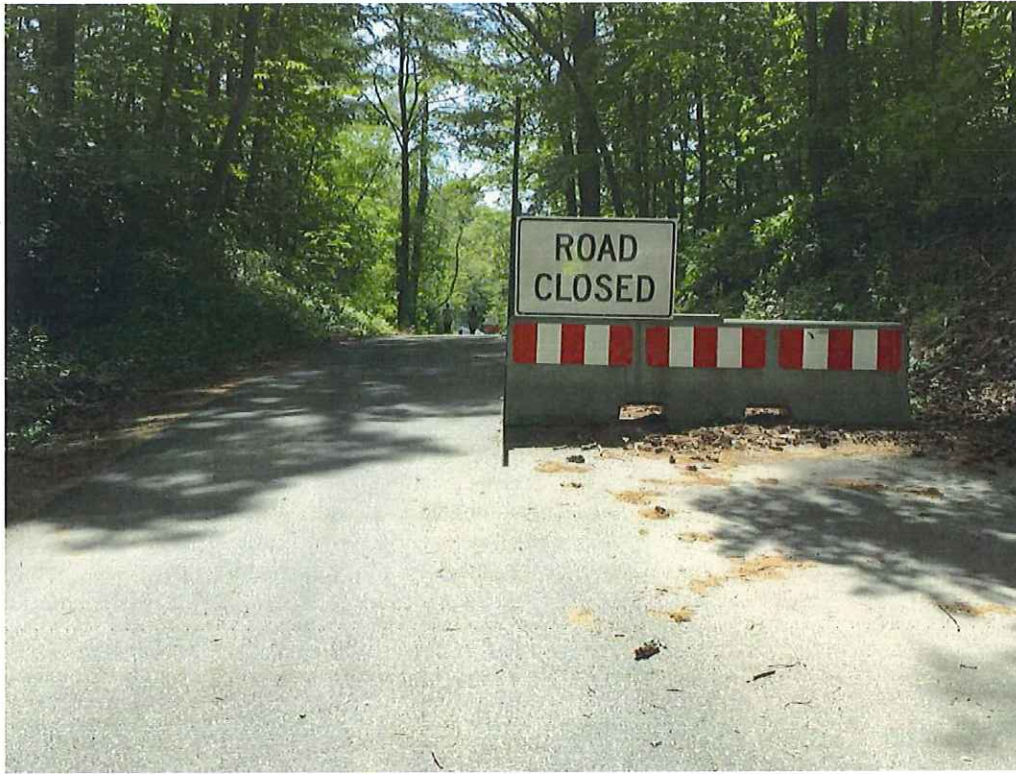
Photo 3: Third "Advanced", "Road Closed" sign with Jersey barrier, west of the bridge.

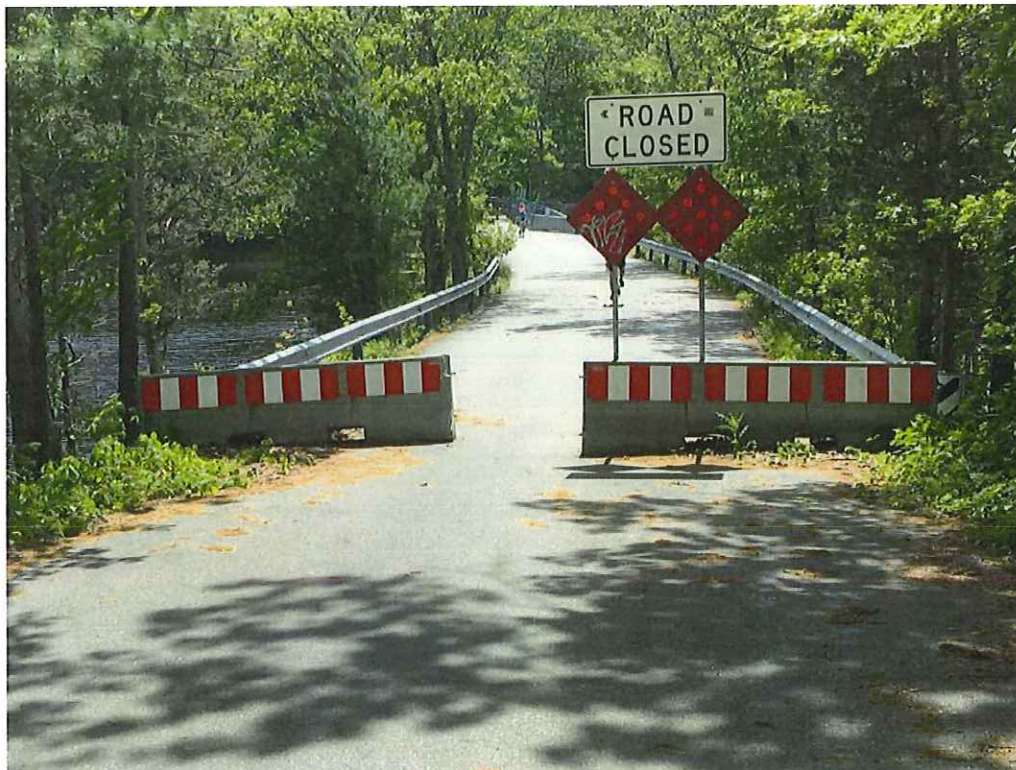
Photo 4: West approach Jersey barriers and "Road Closed" sign.

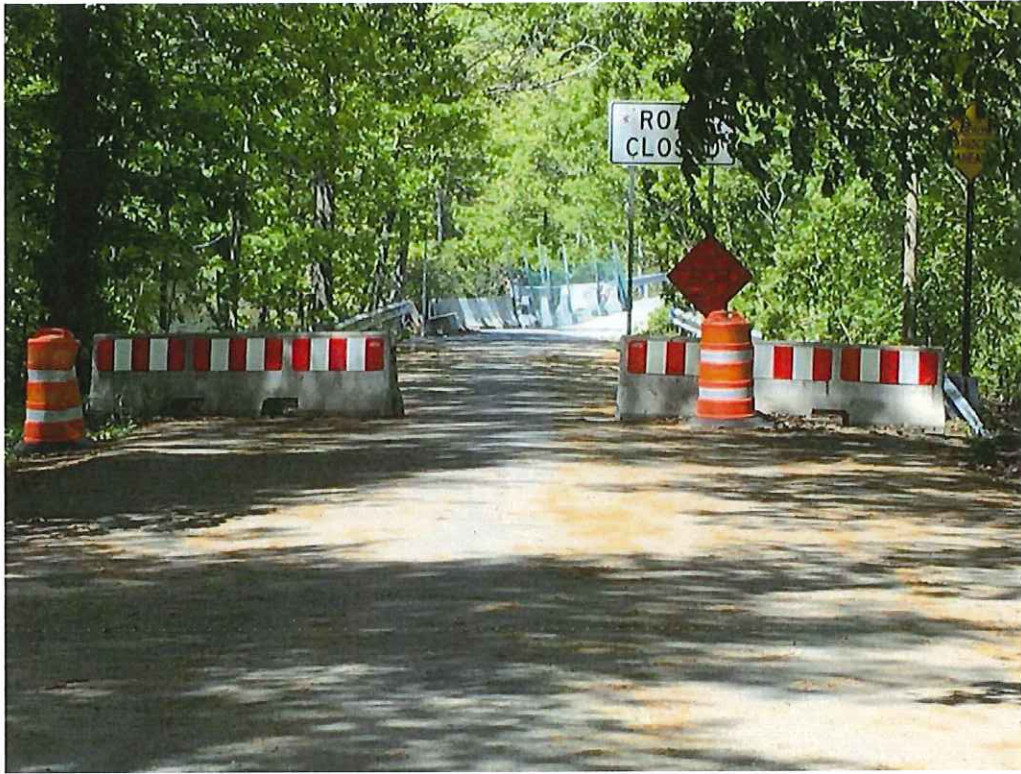
Photo 5: East approach "Road Closed" sign with Jersey barriers.

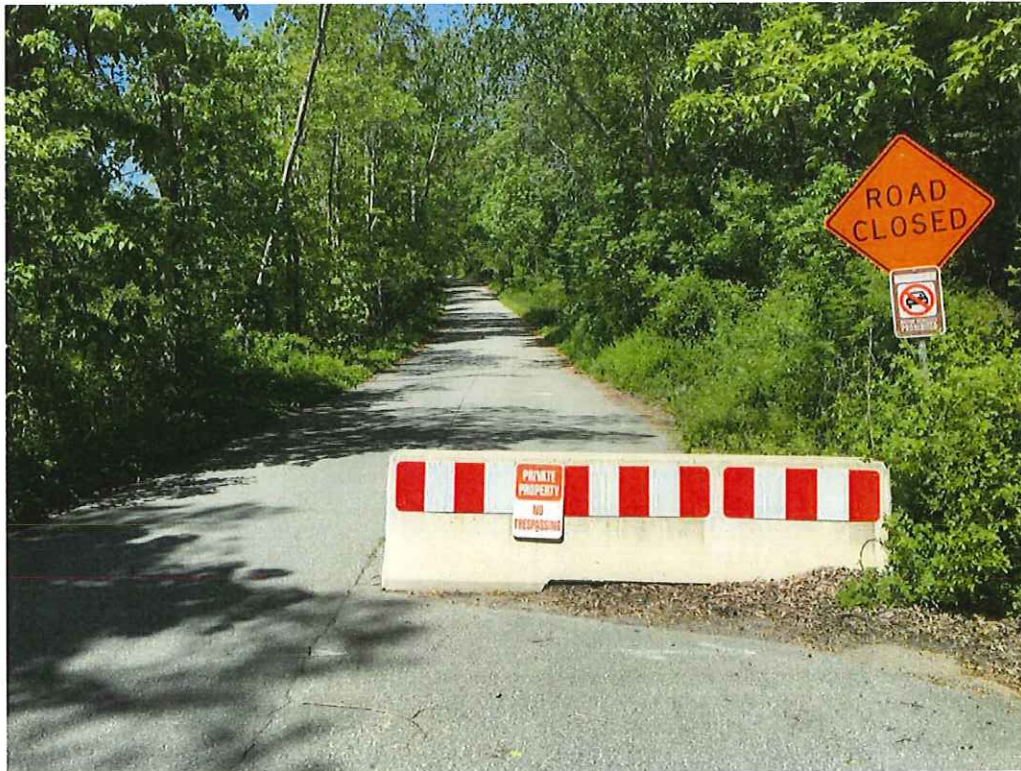
Photo 6: Second advanced, "Road Closed" sign with Jersey barrier, east of the bridge.

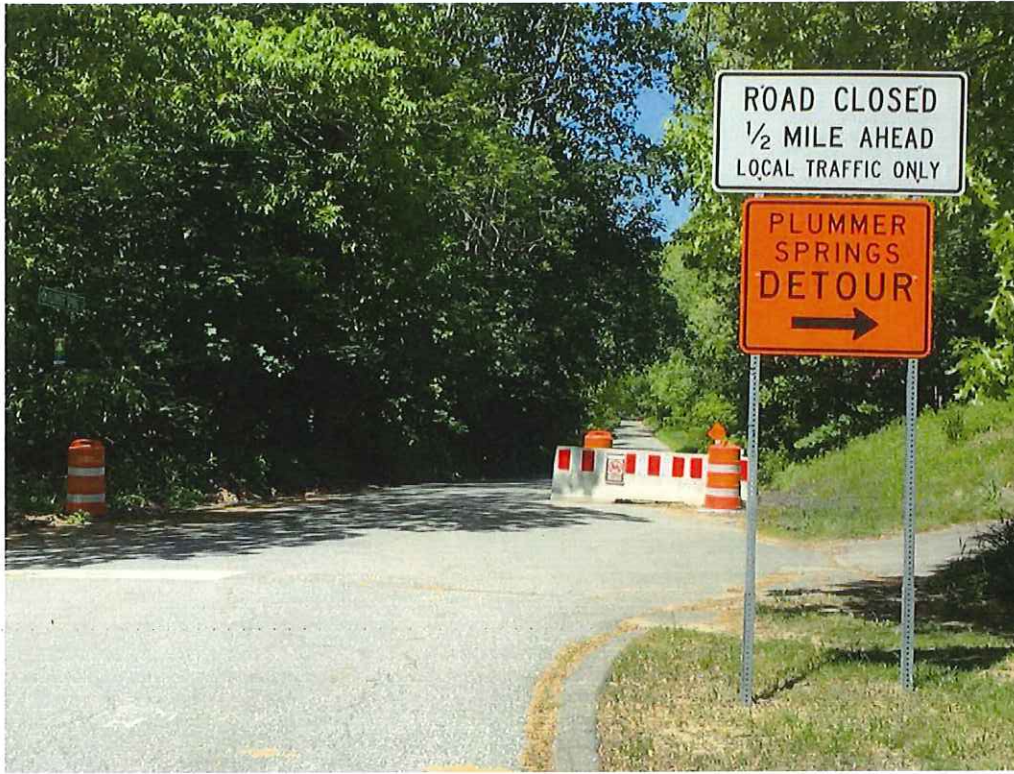
Photo 7: First advanced, "Road Closed" and "Detour" signs with Jersey barrier, east of the bridge.

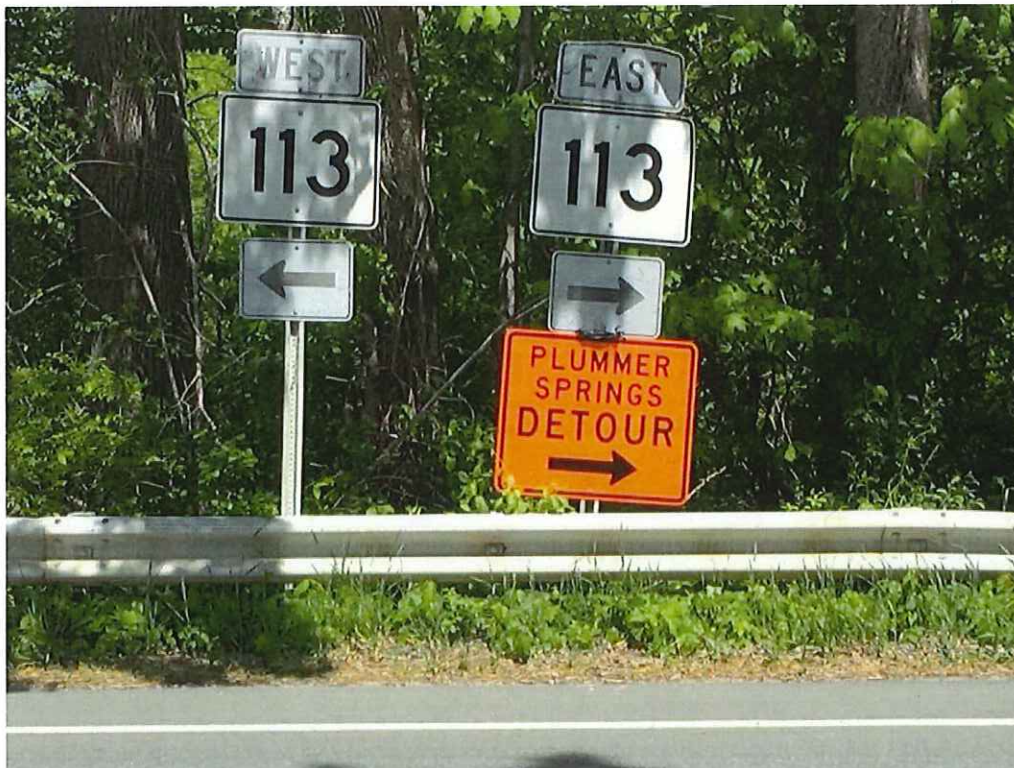
Photo 8: "Detour" sign on Route 113.

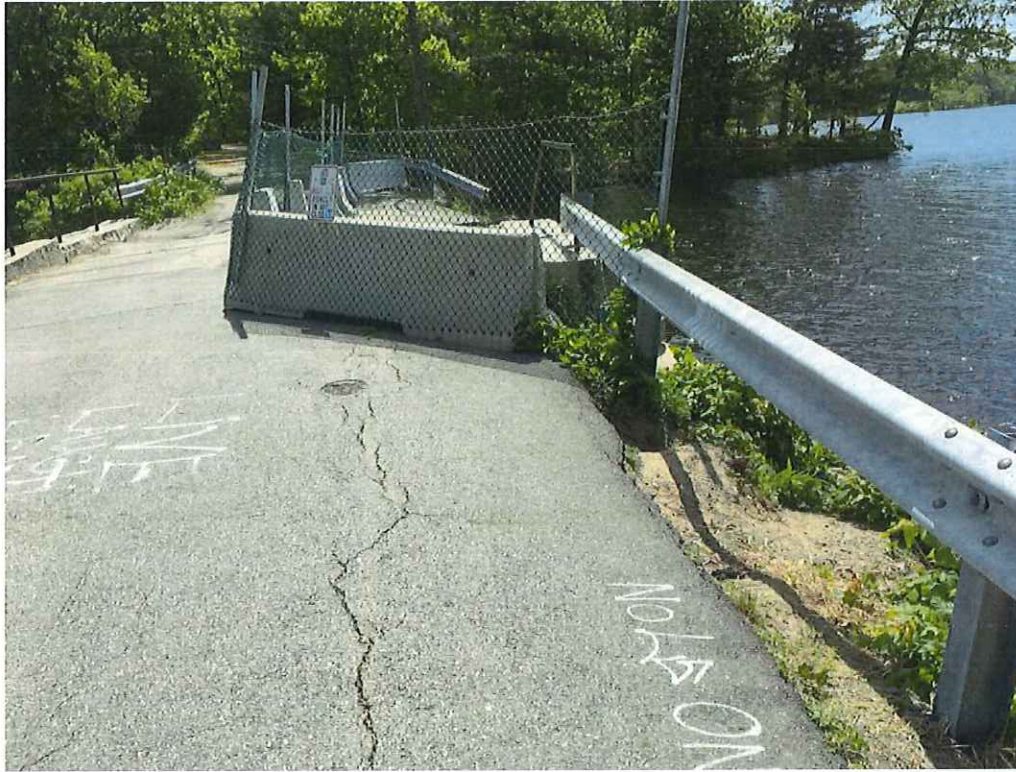
There are Jersey barriers with 6' high chain link fencing along the south side of the bridge preventing pedestrians from accessing the collapsed area. **(Photo 9).**

Photo 9: Jersey barriers with 6' high chain link fencing along the south side of the bridge. (West end shown, looking east).

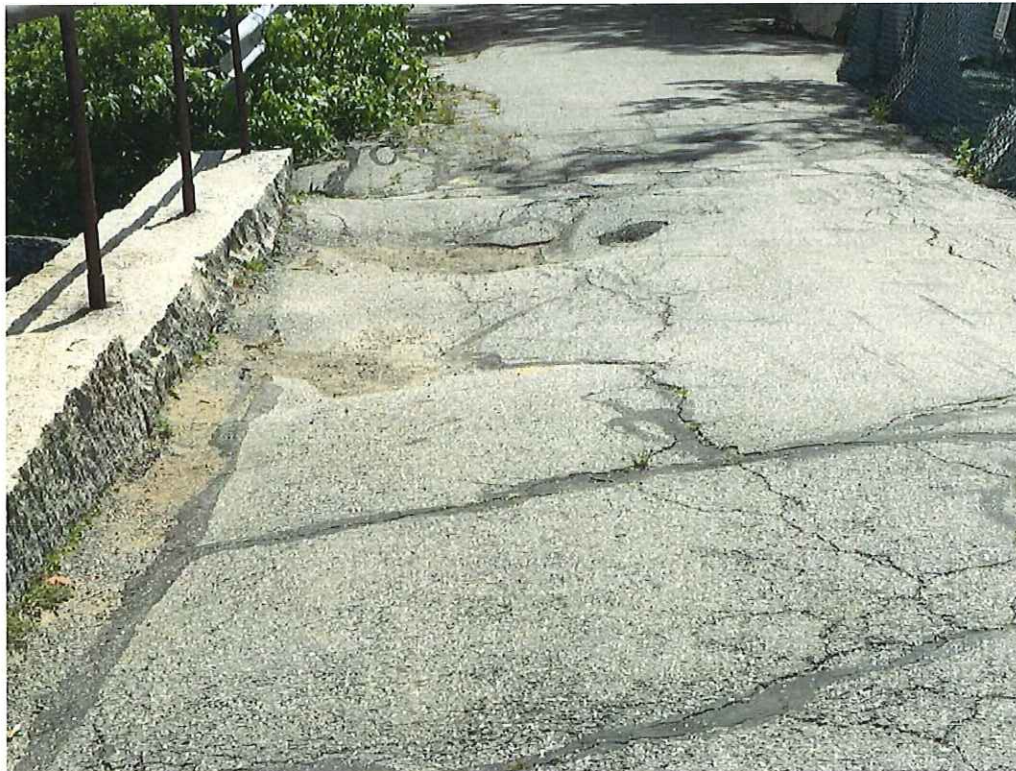
There are areas of heavy settlement and depression along the north spandrel wall (heaviest at the east end up to 1' deep), on the north side of the bridge and adjacent to the north railing. This side of the bridge is currently open to pedestrian traffic. This wearing surface settlement shows the progression of the deterioration since last inspection. **(Photos 10 & 11).**

Photo 10: Areas of heavy settlement and depression along the north spandrel wall (heaviest at the East end) up to 1' deep. (Looking East).

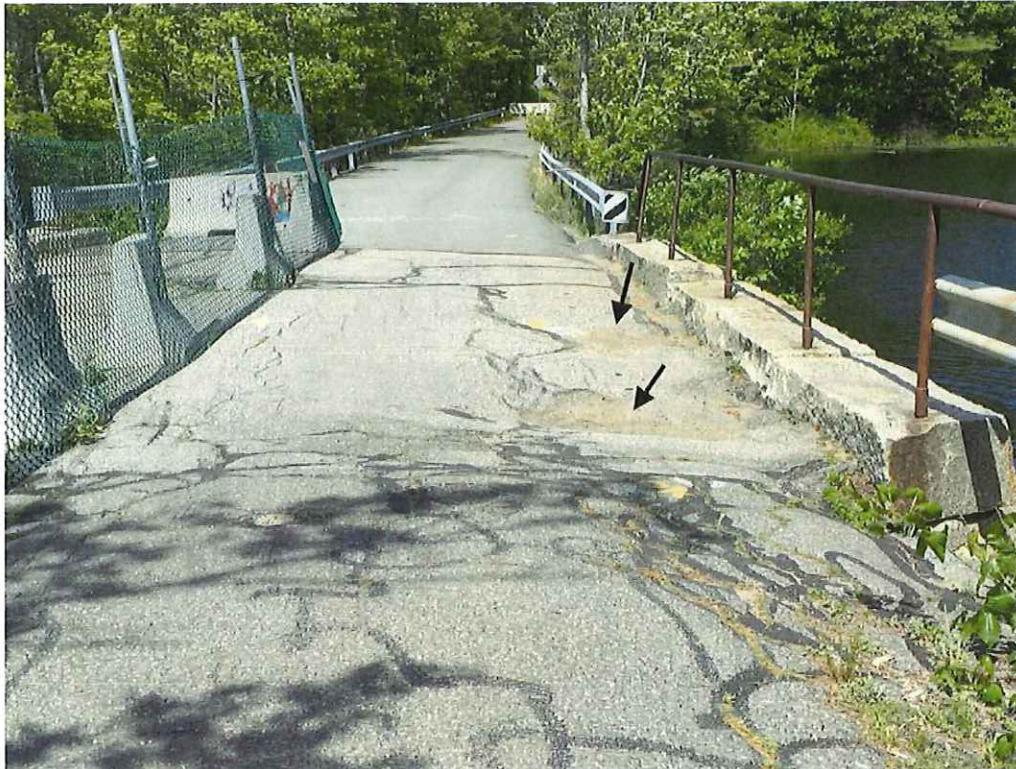
Photo 11: Areas of heavy settlement and depression along the north spandrel wall (heaviest at the East end) up to 1' deep. (Looking West).

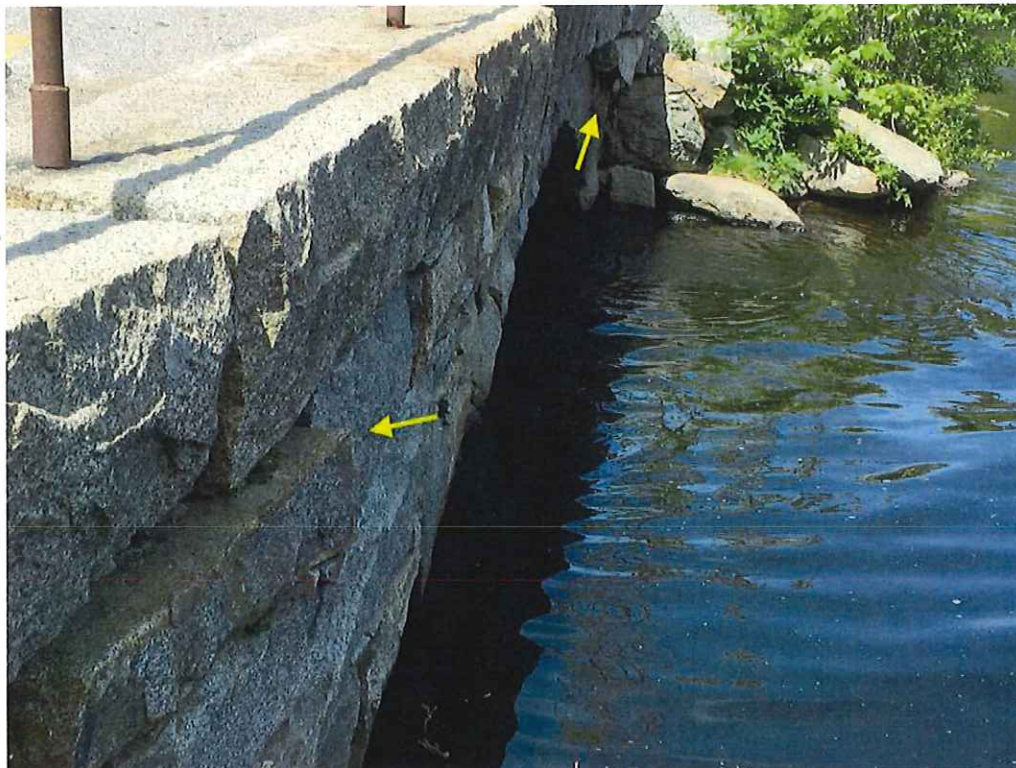
The north spandrel wall shows signs of outward displacement, mostly along the top course and cap stones and up to 5". **(Photo 12).**

Photo 12: North spandrel wall, outward displacement mostly along the top course and cap stones, up to 5".

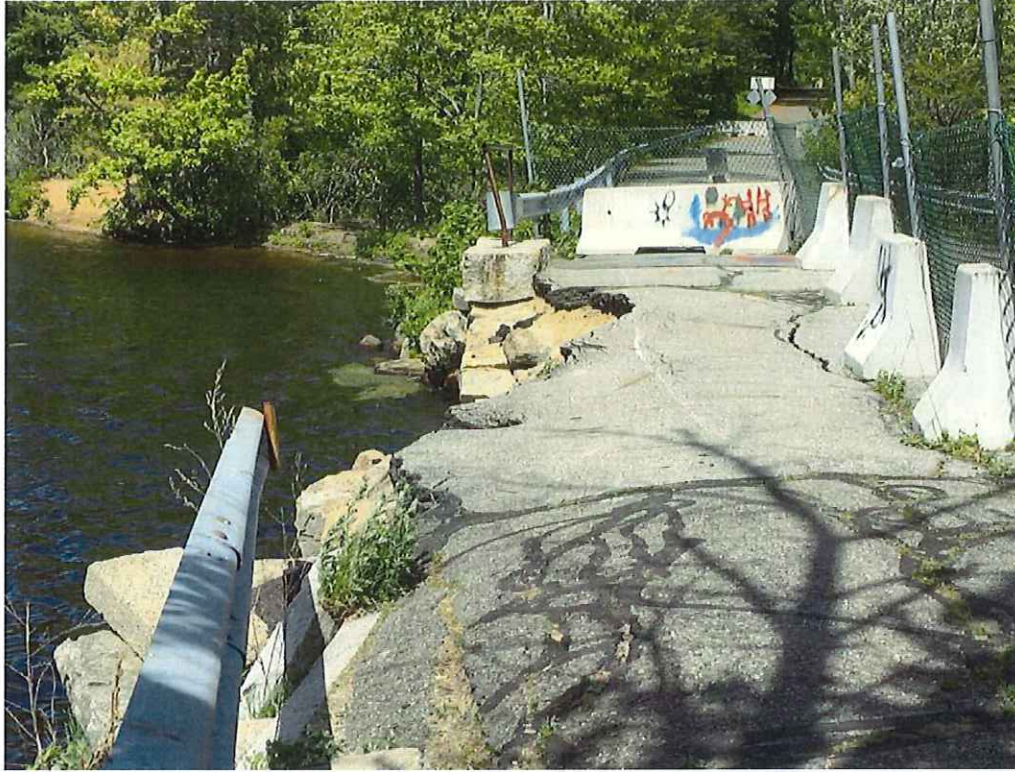
The collapsed area along the south side of the bridge shows signs of the progression of the washout of the sand and filling material under the wearing surface since last inspection dated 6/10/2020. **(Photos 13 - 16).**

Photo 13: The collapsed area along the south side of the bridge. (Looking West).

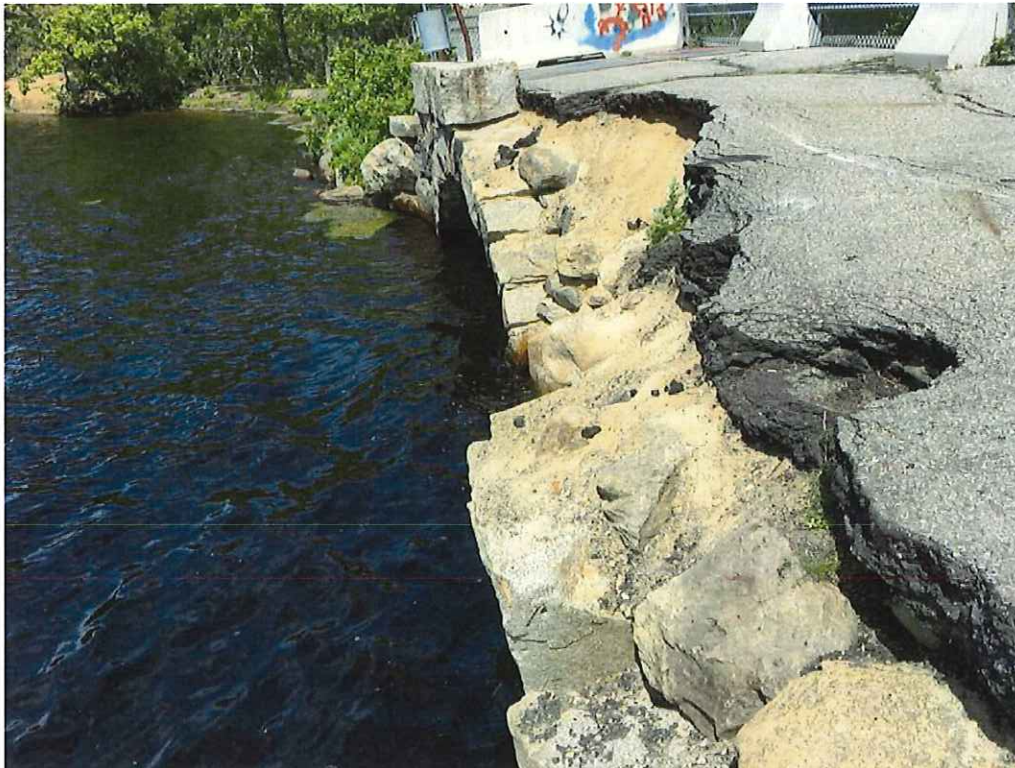
Photo 14: The collapsed area along the south side of the bridge and signs of the progression of the washout. (Looking West).

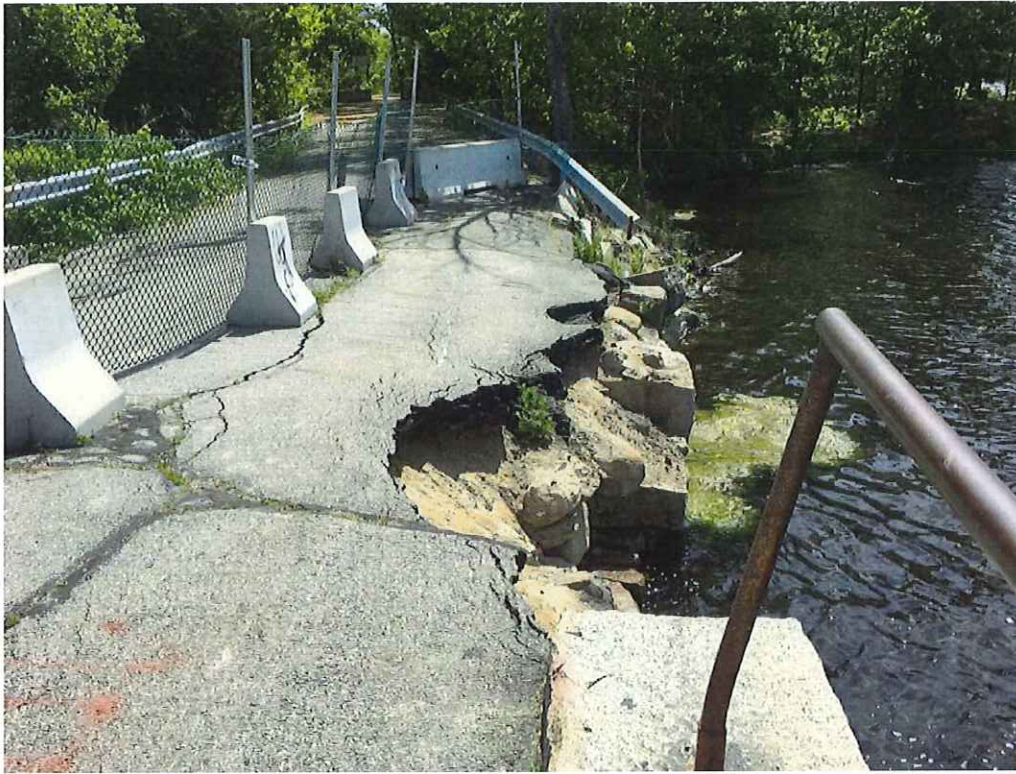
Photo 15: The collapsed area along the south side of the bridge. (Looking East).

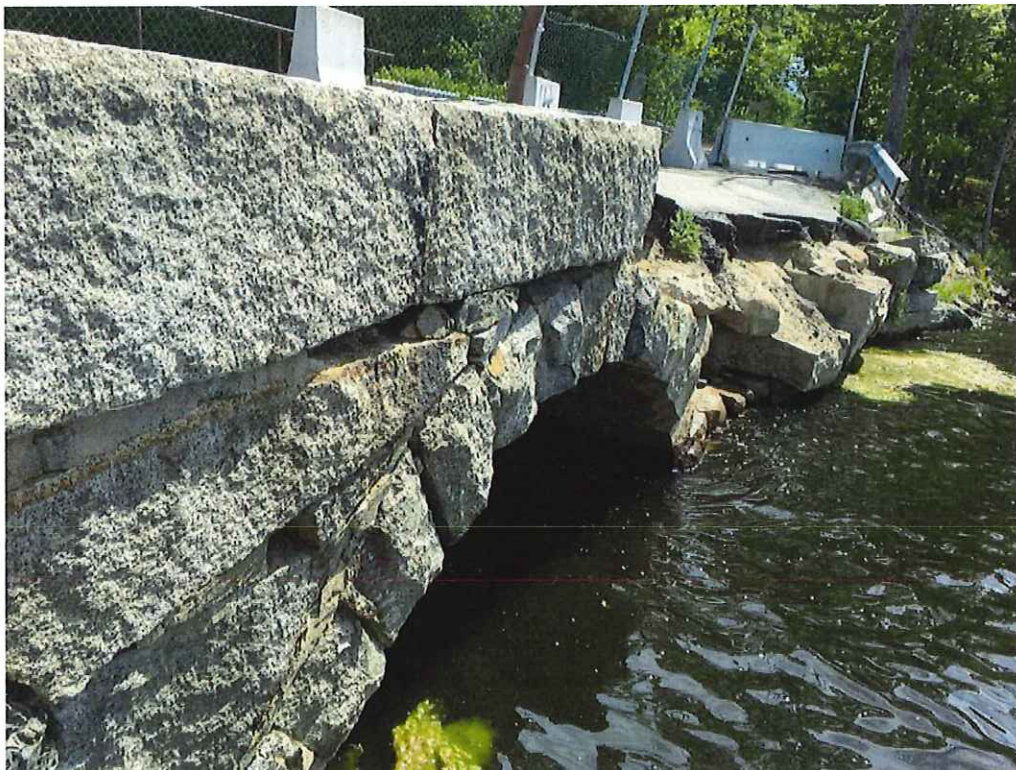
Photo 16: The collapsed spandrel wall along the south side of the bridge.
