STRUCTURES INSPECTION FIELD REPORT
CLOSED/REHABILITATION INSPECTION

BR. DEPT. NO.
N-11-007=W-20-001

CITY/TOWN NEWBURYPORT=WEST NEWBURY	8.-STRUCTURE NO. N11007-8BC-MUN-BRI	11-Kilo. POINT 000.000	90-ROUTINE INSP. DATE JUN 11, 2018	93*- INSPECTION DATE JUN 27, 2019
07-FACILITY CARRIED HWY PLMMR SPRNG	MEMORIAL NAME/LOCAL NAME	27-YR BUILT 1900	106-YR REBUILT 0000	YR REHAB'D (NON 106) 0000
06-FEATURES INTERSECTED WATER ARTICHOKE RIVER	26-FUNCTIONAL CLASS Rural Local	DIST. BRIDGE INSPECTION ENGINEER J. Dideo <i>[Signature]</i>		
43-STRUCTURE TYPE 811 : Masonry Arch - Deck	22-OWNER Town Agency	21-MAINTAINER Town Agency	TEAM LEADER A. Power <i>[Signature]</i>	
107-DECK TYPE N : Not applicable	WEATHER CLEAR	TEMP. (air) 30°C	TEAM MEMBERS Patrick Burke <i>[Signature]</i>

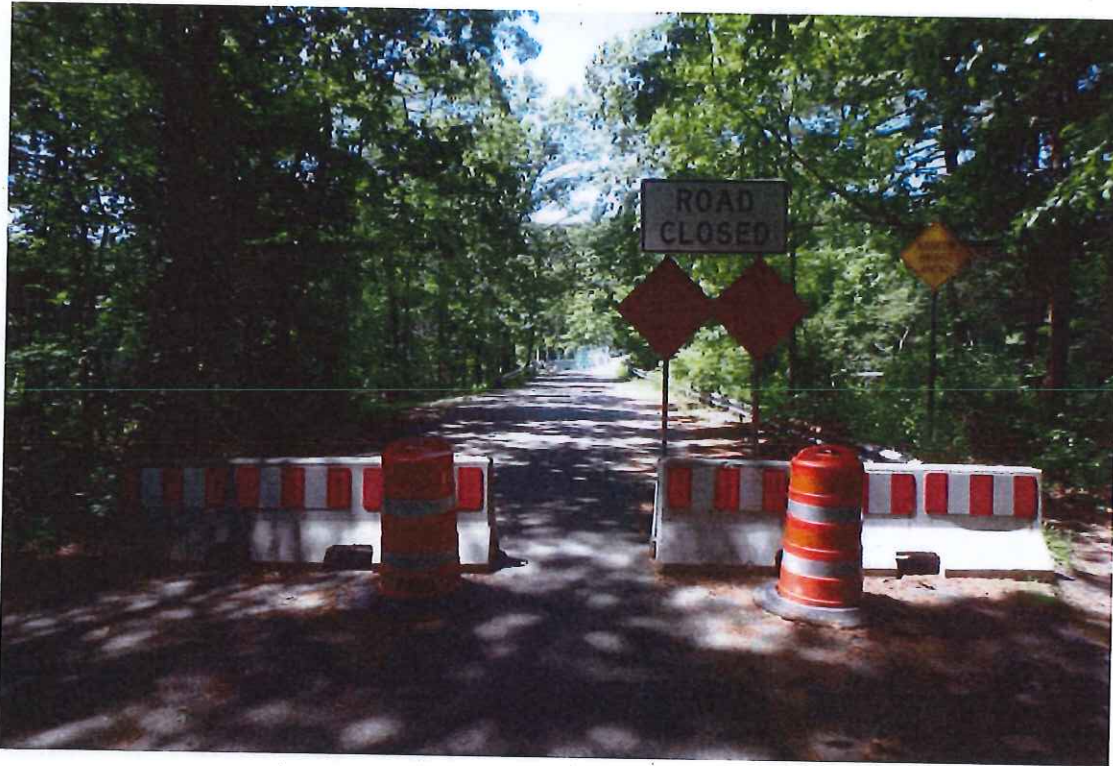
The bridge has been closed to vehicle traffic due to a failure in the spandrel wall at the southeast corner of the bridge. Jersey barriers with 6' high chain link fencing have been placed at the south side of the bridge preventing pedestrians from accessing the collapsed area (see **Photos 1-4**). Road closed and detour signs have been placed at intersections on both sides of the bridge about half a mile away in either direction (see **Photo 5**). Jersey barriers, traffic barrels, and signs are installed between cross streets and bridge warning of closed bridge ahead, but not preventing traffic (see **Photo 6**). Jersey barriers, traffic barrels and road closed signs have been installed at both ends of the bridge preventing vehicle access (see **Photo 7**).

Photo 7: Typical barrier and signage at bridge preventing vehicular traffic. East approach shown.

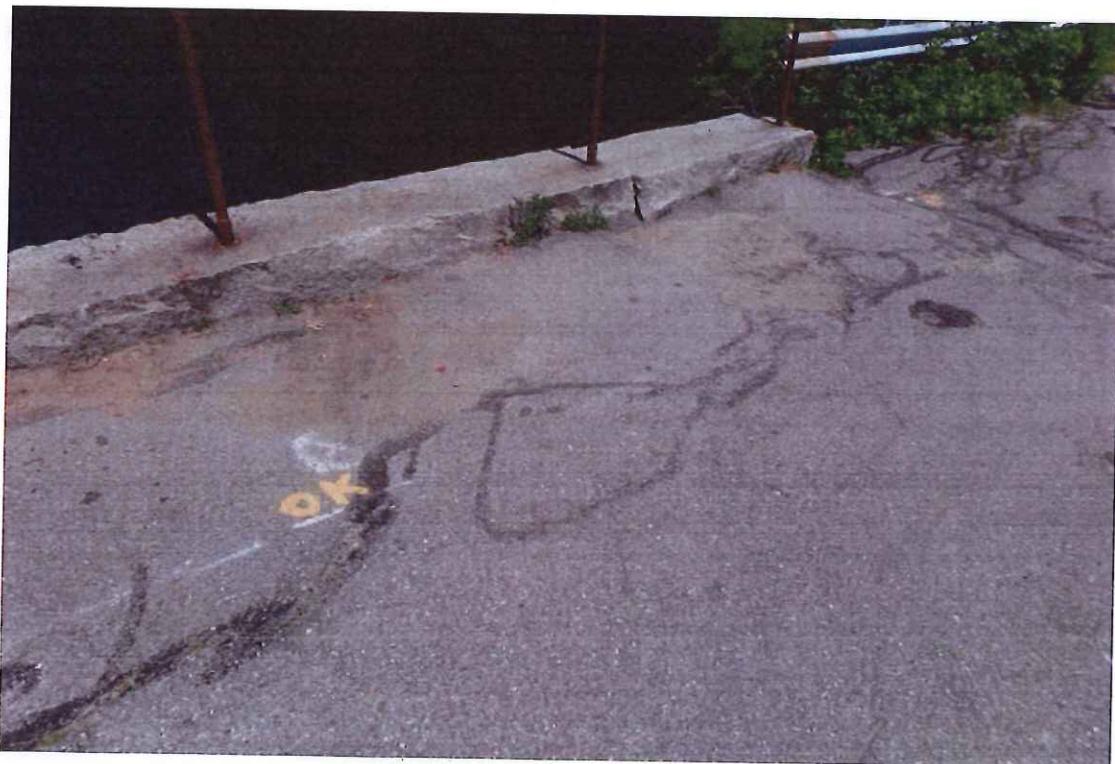
There are signs of additional deterioration on the north side of the bridge (currently open to pedestrian traffic). There are areas of settlement adjacent to the north bridge railing (see **Photo 8**), and bulging of the north spandrel wall (see **Photo 9**).

Photo 8: Settlement areas adjacent to the north bridge railing.

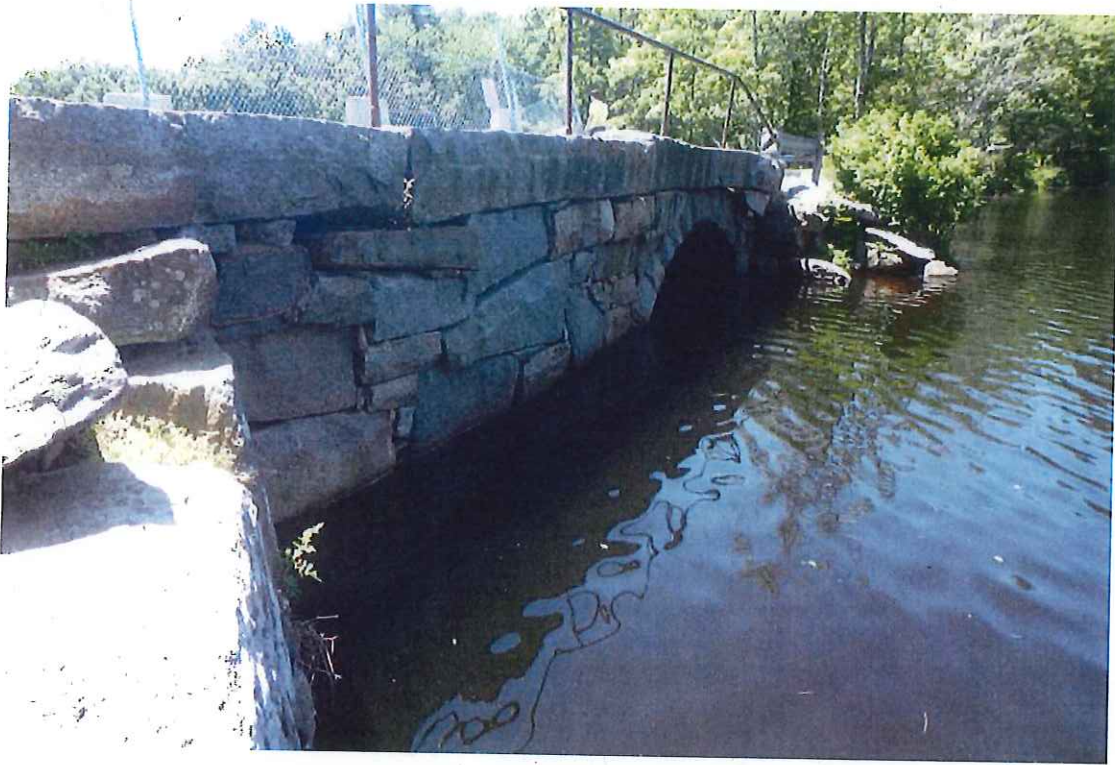
Photo 9: Bulging of the north spandrel wall both east and west of the arch.
