WEST NEWBURY HISTORICAL COMMISSION
Historic Sites Survey Table of Contents
Ash Street

FORM B – BUILDING

Address: 114 Ash Street

Historic Name: Samuel Merrill House

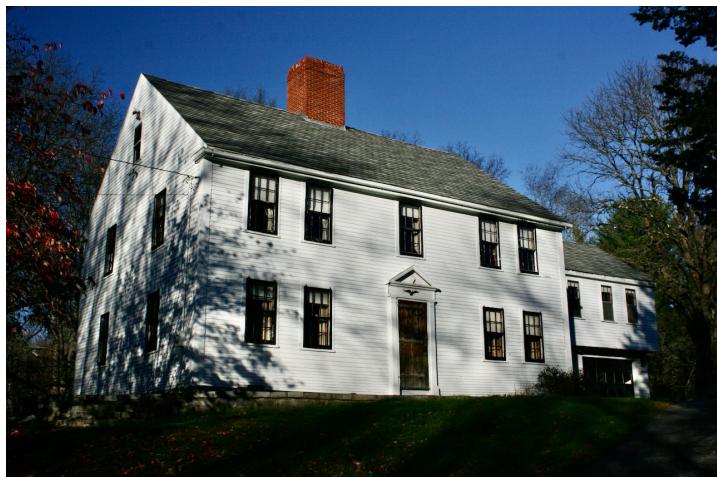
House: Southwest and façade (southeast) elevations.

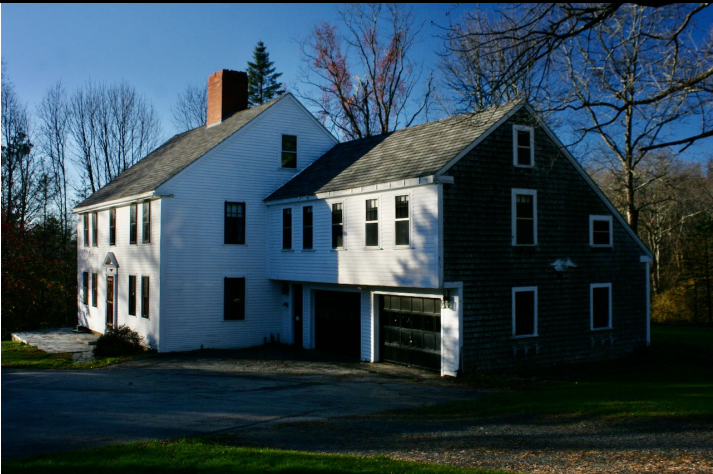
The house consists of a five by two bay main block and an added side ell. Measuring 37 feet wide by 30 feet deep, the main block rises 2½ stories from a granite block foundation to a side gable roof with minimal returns and a substantial center chimney. Clapboard walls are trimmed with flat corner boards and bed molding at the eave. Windows typically feature 6/6 sash with flat casings and wood storm sash and are set close to the roof eave. The symmetrical, five-bay façade (southeast elevation) has a center entrance; its single-leaf, vertical board door is framed by slender pilasters, a wide entablature, and a molded pediment. Windows are loosely paired to each side of the center bay.

House: Façade (southeast) and northeast elevations, main block and ell.

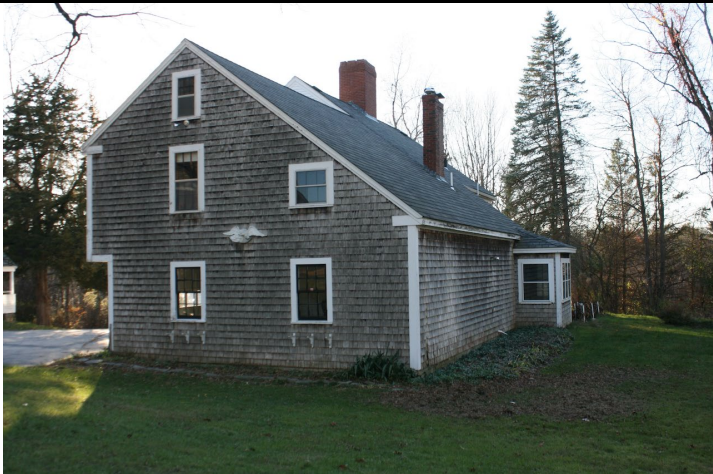
Measuring 30 feet wide by 25 feet deep, the five by two bay side ell extends to the northeast of the main block. It rises 2½ stories to a side-gabled, saltbox roof. Walls are sheathed with clapboard on the façade and wood shingles on the exposed end elevation. Flat corner boards and simple bed molding trim the walls. The façade has an overhanging second story, two garage bays and an offset pedestrian entrance on the first floor, and five symmetrical, 6/6 windows with flat trim on the second story. The rear elevation of the ell is blank; a slender chimney rises from the back slope of the roof. A one-story, hip-roofed appendage projects from the corner between the ell and the main block.

House: Northeast and rear (northwest) elevations (ell).

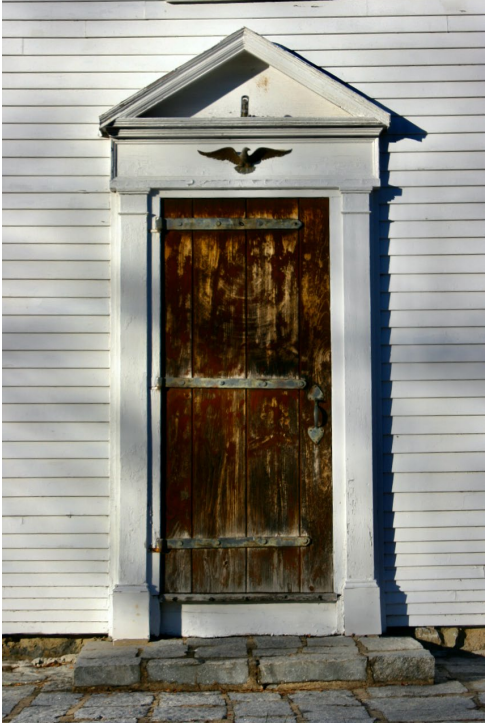
House: Detail of main entrance.

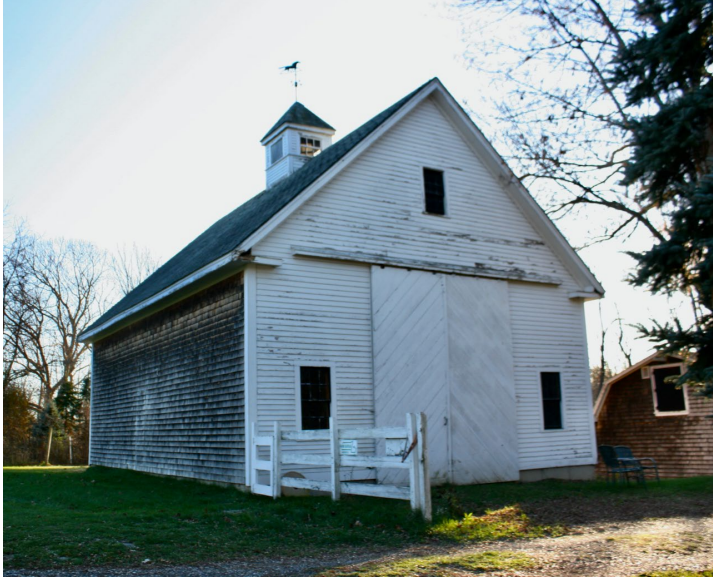
Although modest in its footprint, the principal barn(WNB.420) rises a tall 1½ stories to a front-gable roof crowned with a hip-roofed cupola. The façade (northwest elevation) is sheathed with clapboards; wood shingles clad the side elevations. Walls are trimmed with flat corner boards and simple bed molding; the front gable has thin but pronounced gable returns. Windows are visible only on the façade, where they consist of 6/6 sash with flat casings. The symmetrical façade has a two-panel sliding door with diagonally-set boards flanked by a single window on each side. A smaller window is centered in the half-story. The left side (northeast elevation) is blank. The right side (southwest elevation) has an off-set, sliding pedestrian door constructed of vertical boards. Both sliding doors are protected by a shallow shed-roofed hood. The cupola, square in shape, is sheathed in clapboards and has a 3/3 window on each elevation. Its use of materials suggests 20th century new construction or alteration.

Front-gable barn: Northeast and façade (northwest) elevations.

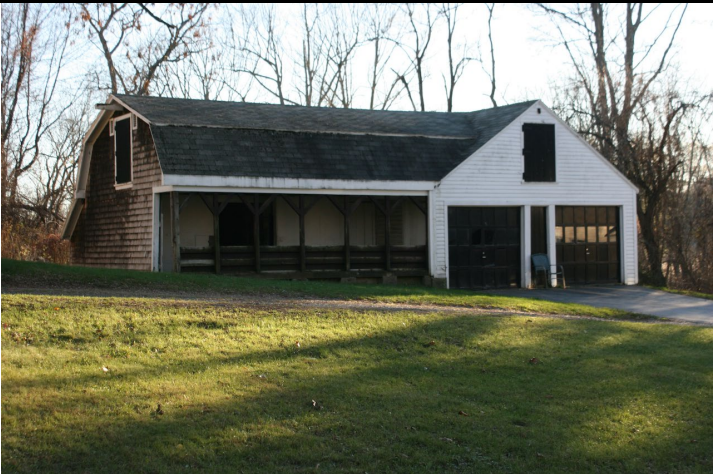
Situated opposite from the house, the smaller barn (WNB.421) in this complex rises 1 story from a concrete block foundation to a side-gambrel roof with a cross-gabled projection on the southwest end. A narrow, shed-roofed extension spans the rear of the building. Walls are sheathed with clapboards on the façade and wood shingles on the sides and are trimmed with flat corner boards; no gable or gambrel returns. A recessed porch spans the façade of the gambrel-roofed end of the barn, supported by rustic posts and cross braces. The cross-gabled projection is symmetrically fenestrated with two garage bays on the first floor and a vertical-board barn door in the half-story. The right side (southwest elevation) contains a single 6/6 window in the center; the left side (northeast elevation) side has a large, vertical-board barn door in the half-story.

Gambrel Barn: Northeast and façade (northwest) elevations.

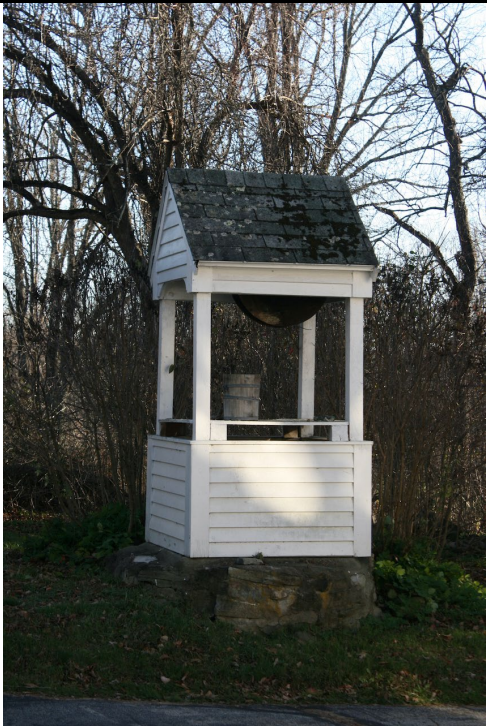
Opposite the main block of the house is a small wood well structure, which may be a modern replica, atop an historic stone foundation. Square in shape, it has low clapboard walls, 2x- corner posts, and a gabled roof.

Well structure: Northeast and northwest sides.
